## Visit Report

| Commande BSTe France : SER230725rev1 | | Intervention. : E1738 | |
| Customer : | BBC CELLPACK Packaging | System : | iPQ View |

Machine Manufacturer/Model/Nickname : [Schiavi / SG 1200 / i69](#)

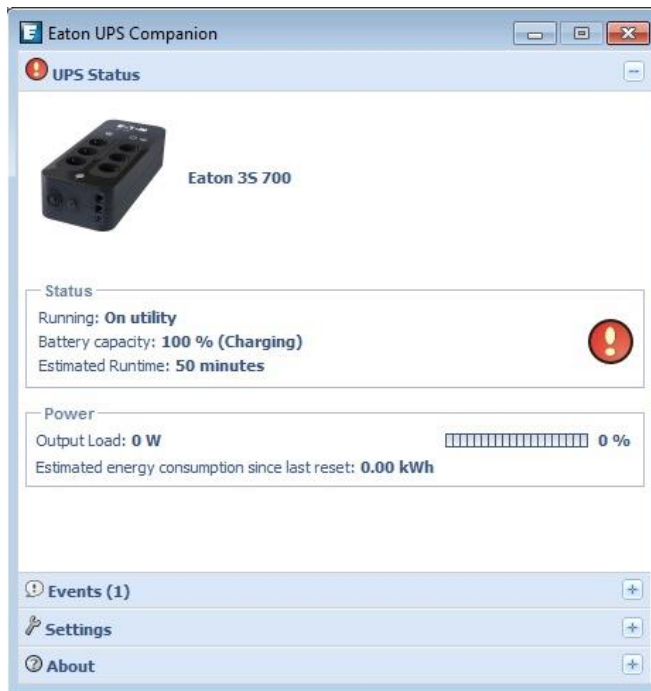
1 – [UPS Eaton 3S 700](#)                      3 – [Filters](#)  
 2 – [16 Flash Bulbs](#)

### 1- UPS Eaton 3S 700 down

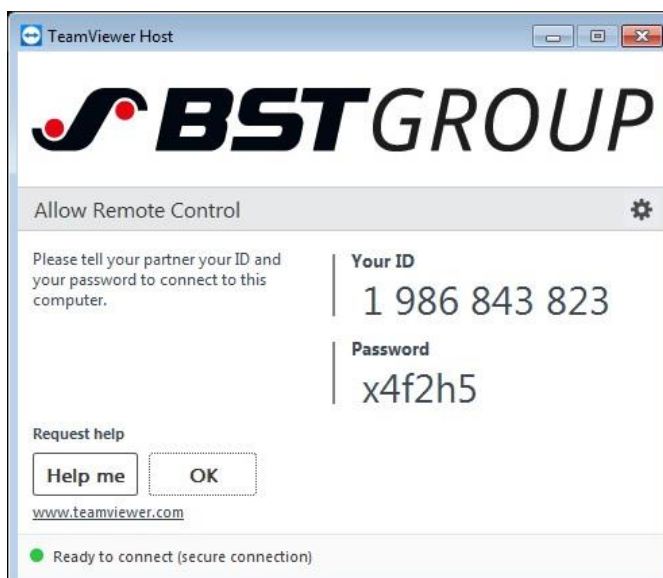
### 2- Teamviewer

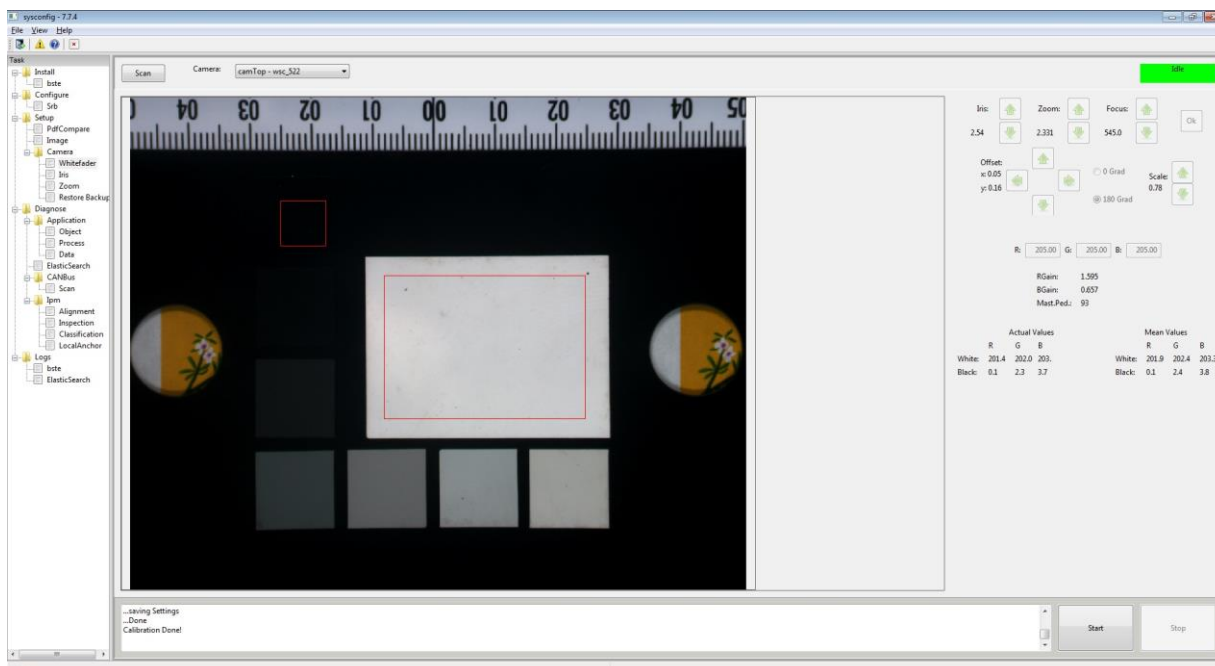
#### a- White Fader

### 3 – Front Camera Calibration

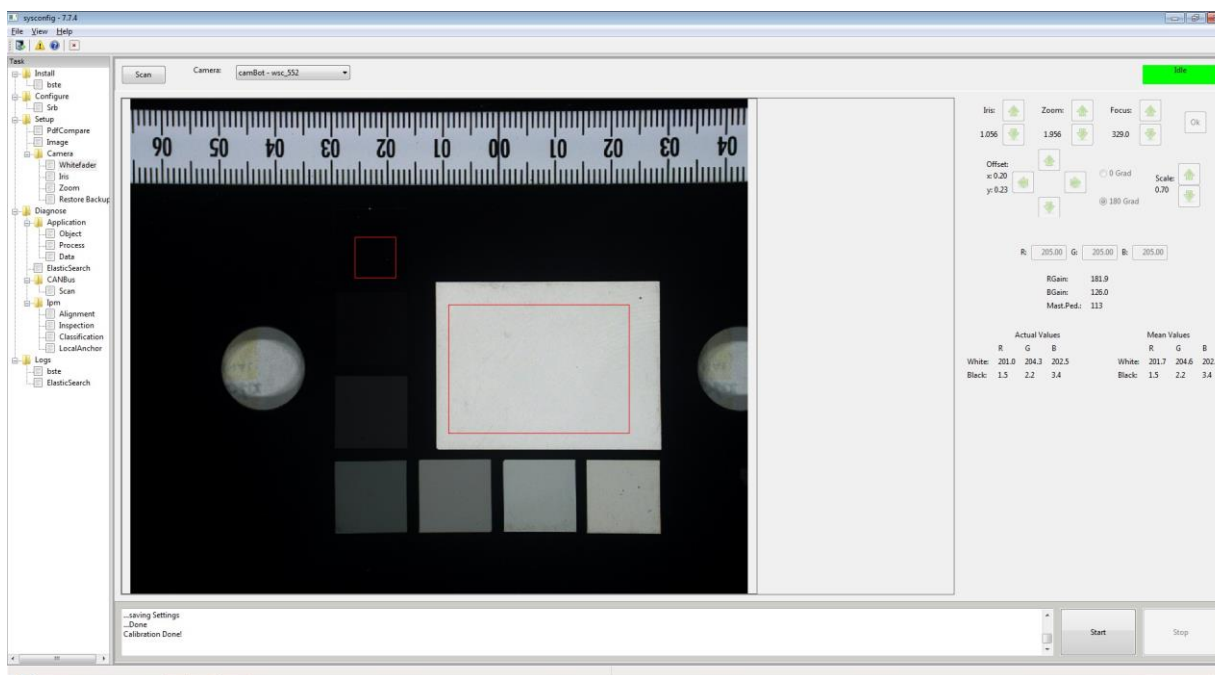
### a- White Fader

## 4 – Back Camera Calibration
