## Visit Report

| Customer : | Cosapack | System : | iPQ View |

| Details | Preventive Maintenance on iPQ System. |

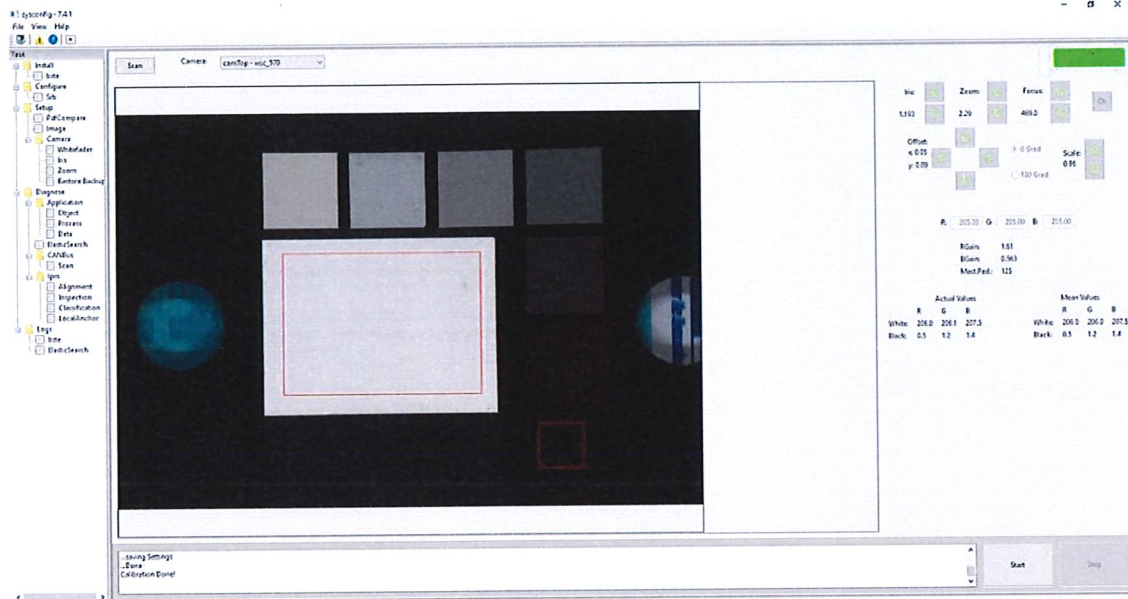
### - White Fader calibration

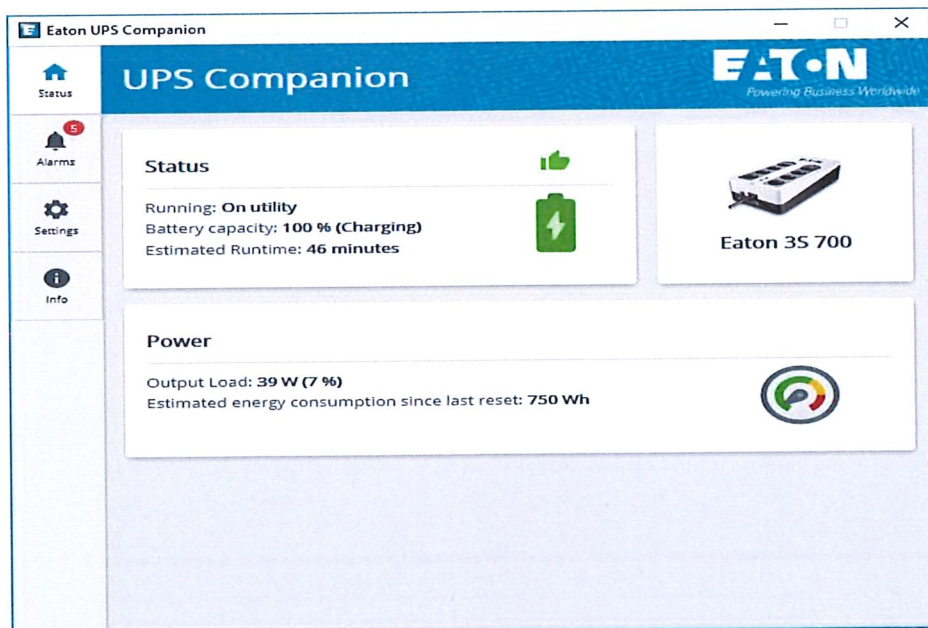
### - UPS Eaton S 700 IEC settings checked.
