## TubeScan DS 660 sur Die Cutting machine Berhalter (566) / B6 (SN1360-CE-6)

### 4K Inspection Camera – DS 660 HR3

## **8K Inspection Camera – DS 660 8K**

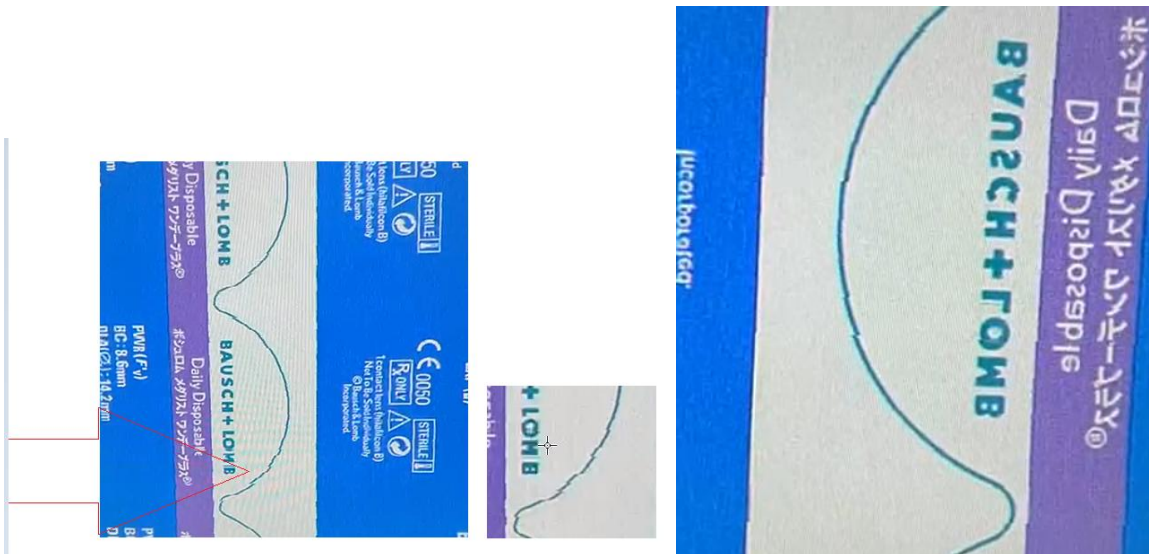
Due to vibrations generated by the 566 machine itself, as well as resonance propagated from surrounding equipment, intermittent image distortion (stuttering effect) has been observed. This phenomenon limits the ability to fully leverage the system's inspection performance.

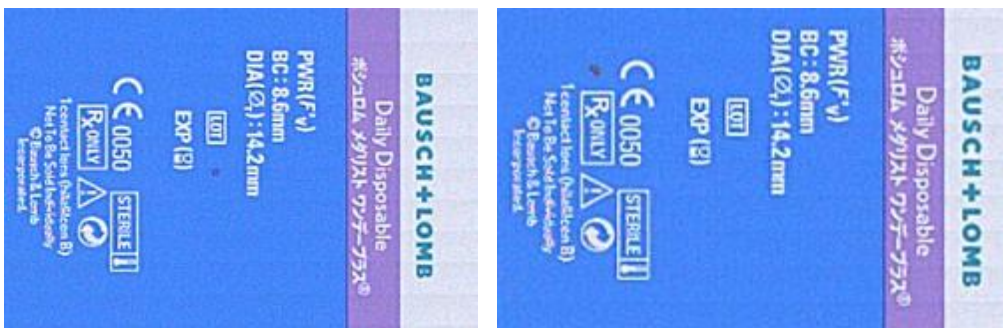
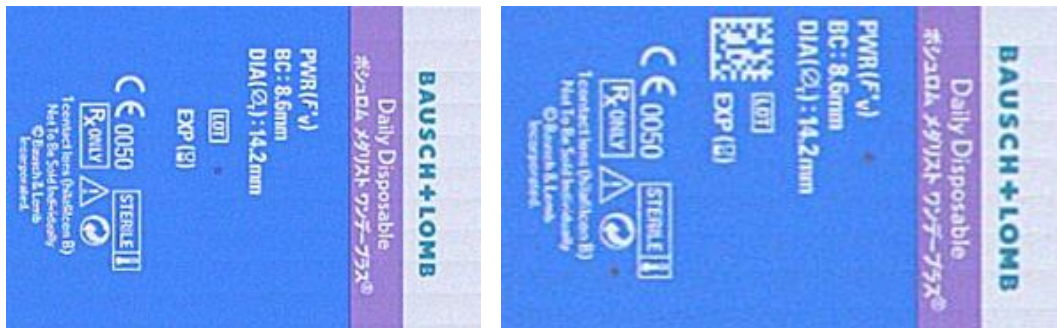
## Test 1

Final Assessment: All artificially generated or pre-existing defects in the background print area were reliably detected. Since the 0.34 mm<sup>2</sup> sensitivity threshold met the detection requirements, further testing at 0.17 mm<sup>2</sup> was not deemed necessary for this camera.

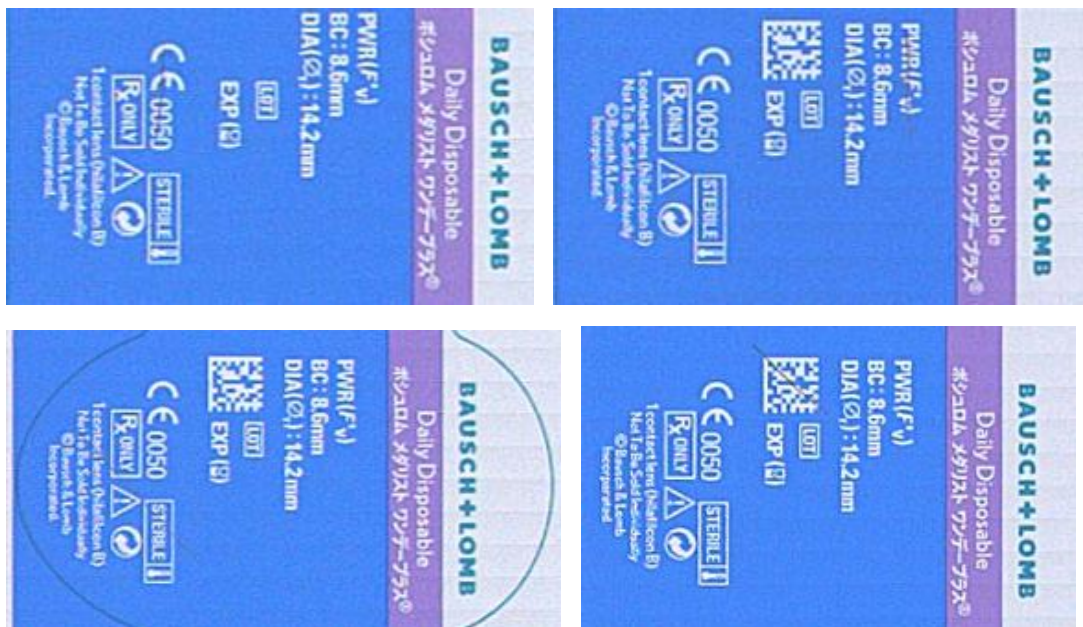
## Test 2

Final Assessment: Defects were intermittently captured. As the same defects could not be reproduced identically, a margin of uncertainty remains in the test results. Overall, line-type defects were detected inconsistently and in a non-repeatable manner..

The 0.17 mm<sup>2</sup> sensitivity setting could not be reliably used in structured zones due to residual vibrations. This resulted in false detections or artifacts in the 'Edge' areas.

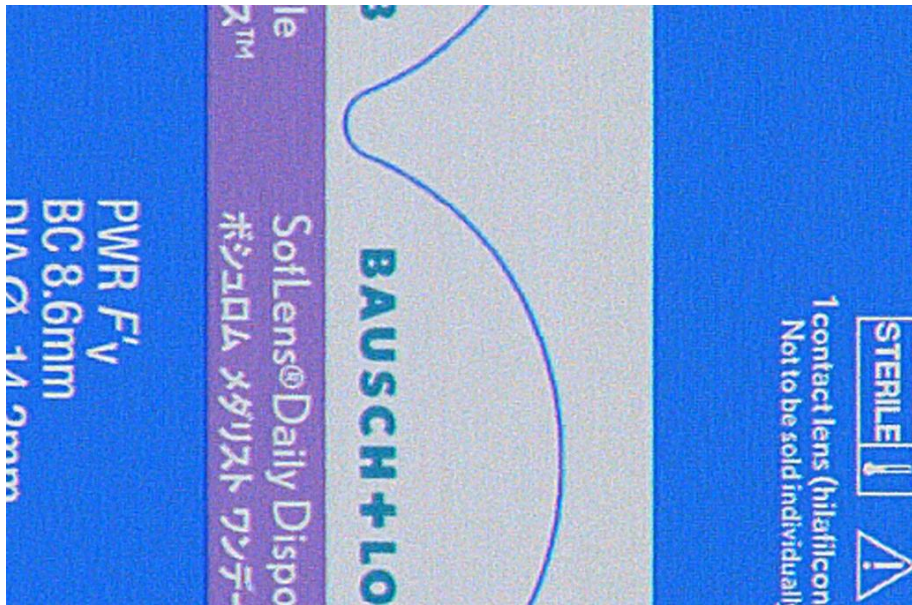
The vibrations generated by this machine were significantly reduced but not entirely eliminated.  
Shockwaves transmitted from nearby equipment remain perceptible.

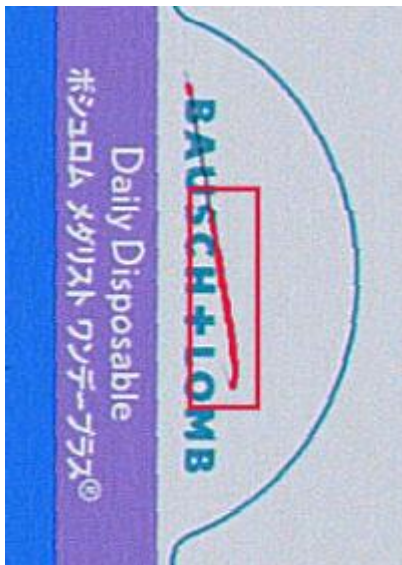
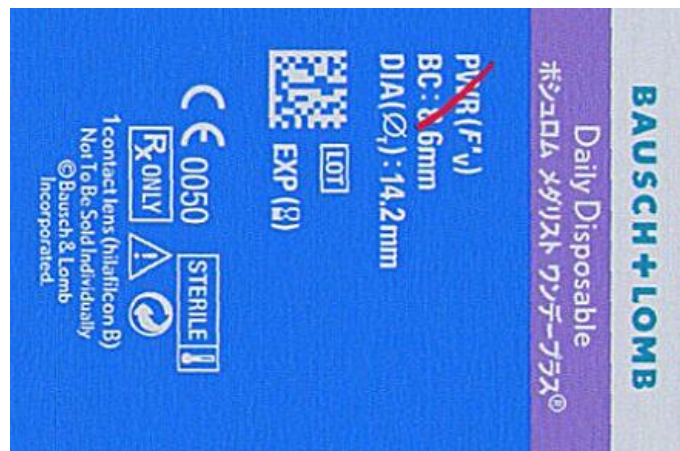
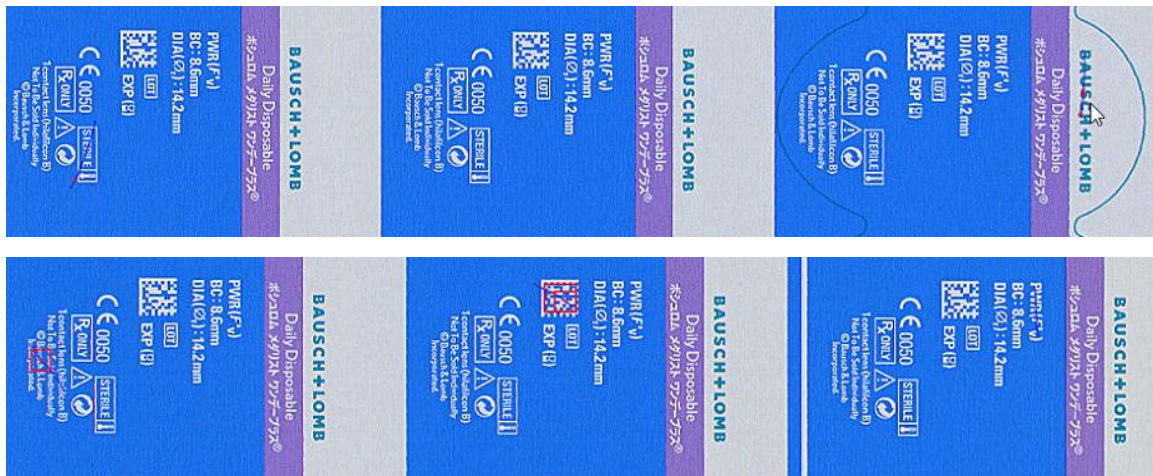
## Test 2

**Final Assessment :** Defects were intermittently captured. Since identical reproduction of the defects was not possible, a certain degree of uncertainty remains in the test results. Defects were more consistently detected at 0.34 mm<sup>2</sup>, but some were also captured at 0.17 mm<sup>2</sup> on occasion.

Inspection at sensitivities below 0.17 mm<sup>2</sup> in structured areas proved unmanageable due to residual vibrations, leading to false positives or unstable detection in structured print zones.
