## Visit Report

| Details | Maintenance préventive du système Registar_20 sur presse DCM BIVA 2. Backup . |

## Maintenance Checklist for Registrar\_20

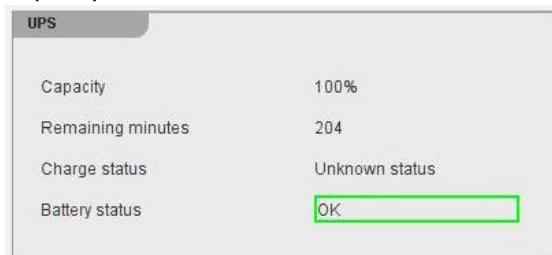
**1- Onduleur**

Vérification statuts UPS par logiciel interne maintenance BECKHOFF.

- Battery status : OK
- Capacity : 100%

Batterie a changé tous les 5 ans

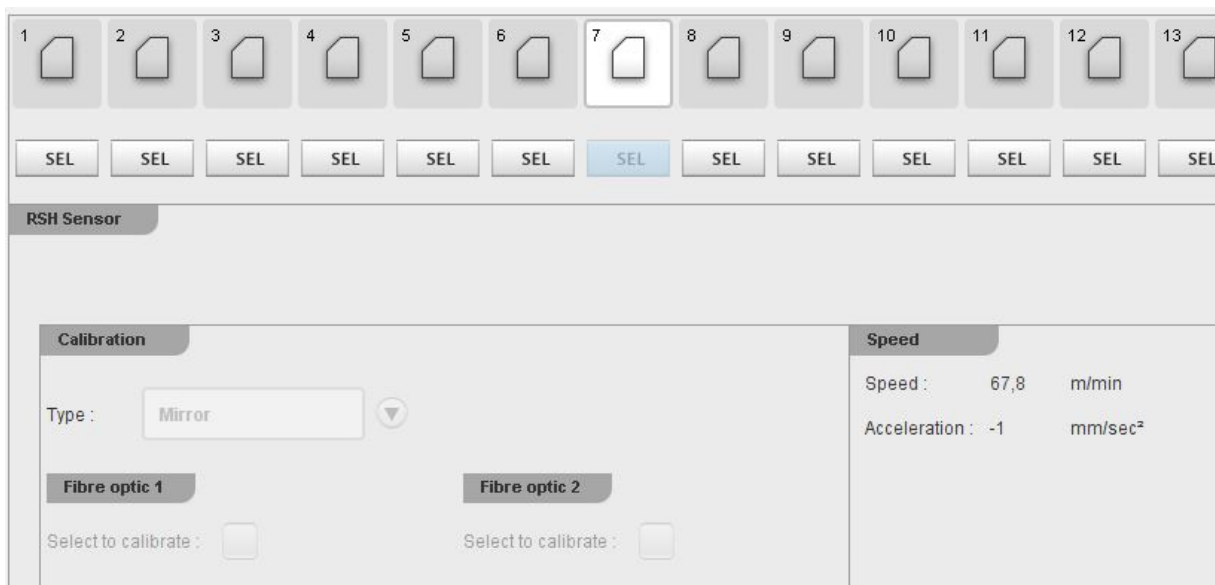
### Moteur indépendant :

Vitesse Stable entre chaque Groupe d'impression. ATTENTION PU 6-7 VARIATION ACCELERATION, il faut vérifier accouplement ou motorisation
