## Visit Report

| Customer : | Logre Imprimeurs | System : | Inspection System |

## Maintenance Checklist for NYQUIST Systems

System Type : [Helios II 330 mm B/W](#)

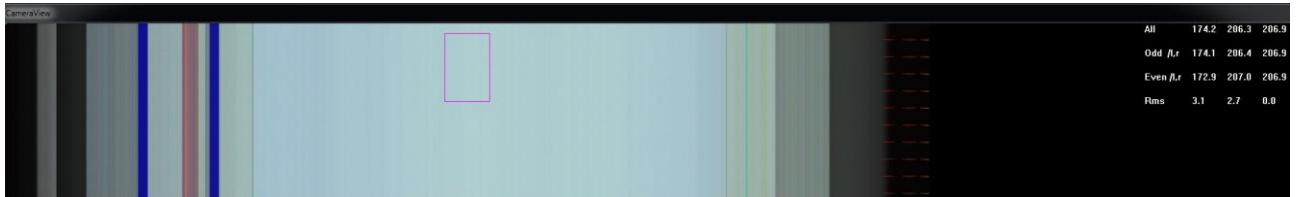
- Before Calibration & Lamps replacement

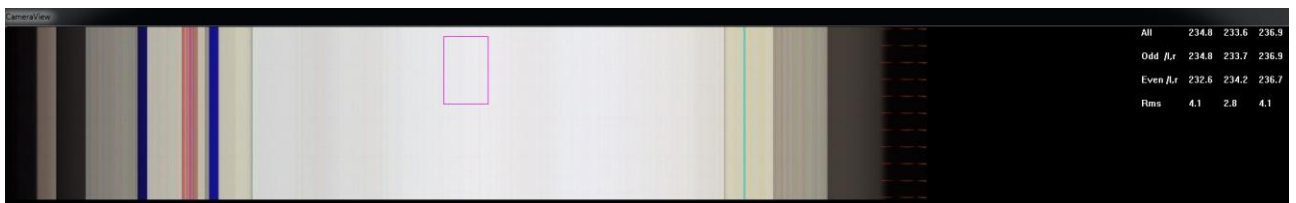
- Before Calibration & Lamps replacement
