## Visit Report

| Customer : | CCL Package Label | System : | TubeScan DS 330 4K |

| Details | Maintenance Préventive du système TubeScan sur presse Gallus EM 280. Mise a jour du system Réglages Tubescan. |

## Maintenance Checklist for NYQUIST Systems

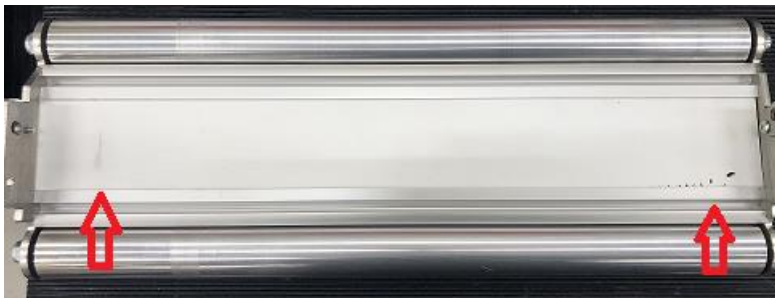
- White/Black back plate scratched

| 1 - Back plate | 3 - |
