## Visit Report

## Maintenance Checklist for NYQUIST Systems

System Type : [Helios S 430 mm](#)

Machine Manufacturer/Model/Nickname : [BOBST / M5 430 8K / BOBST](#)

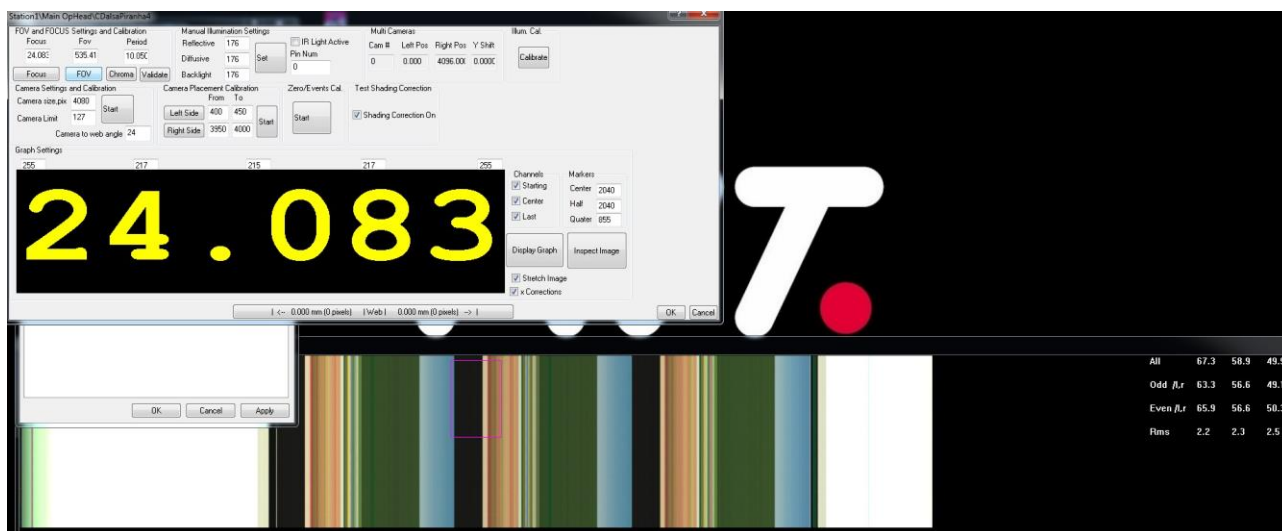
### 2- Field of View

- Field of View / Period 10.05 : 535.41 mm ☒ ☐ ☐
- Offset/Gain Calibration. ☒ ☐ ☐
- Zero LED calibration : Anyspeed & Position : (Events) ☐ ☐ ☒
