## Visit Report

| Customer : | CCL Package Label | System : | TubeScan DS 330 4K |

| Details | Maintenance Préventive du système TubeScan sur presse Gallus EM 285.<br>Mise à jour du système |

## Maintenance Checklist for NYQUIST Systems

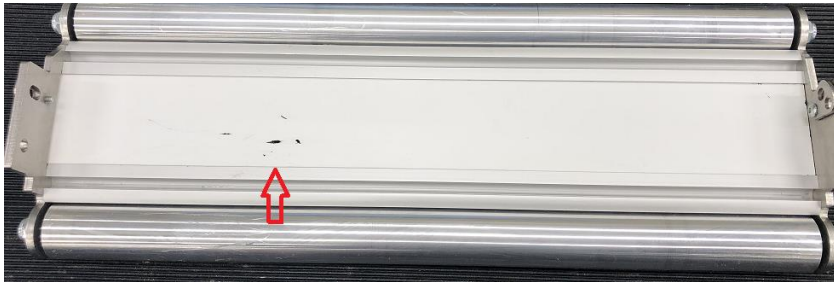
- White/Black back plate scratched.

2 – [Back Plate](#)

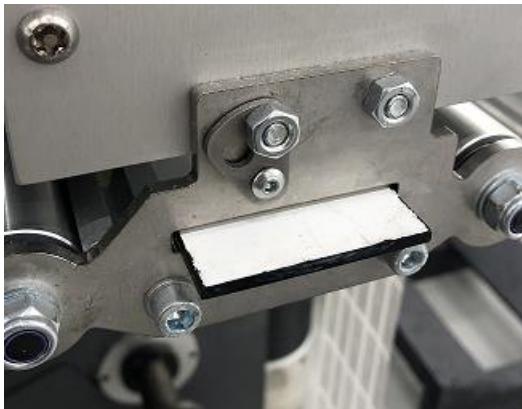
- Screws for Roller Backing Bar missing
