## Visit Report

| Customer : | Atlantique Packaging (Cotentin) | System : | Apollo |

| Details | Maintenance Préventive du système d'inspection Apollo sur presse Cerutti. |

## Maintenance Checklist for AVT Systems

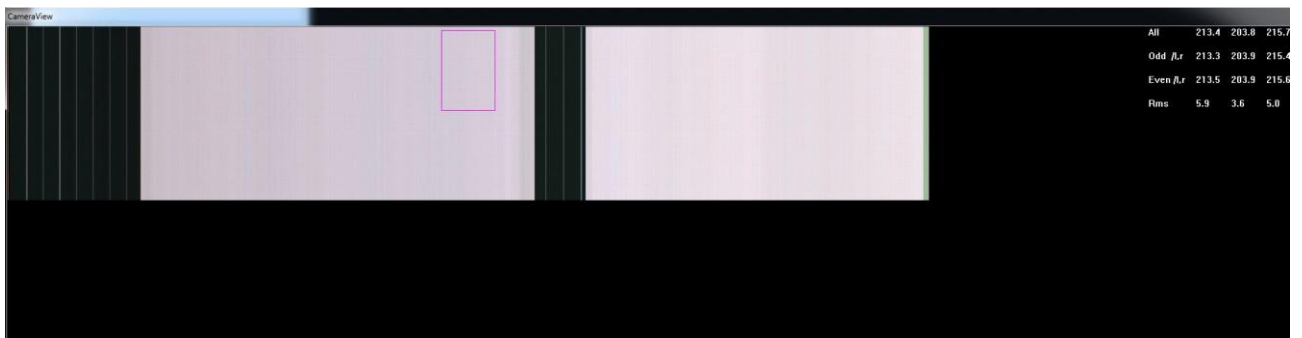
- Before Gain Offset

### - Main OpHead Calibration

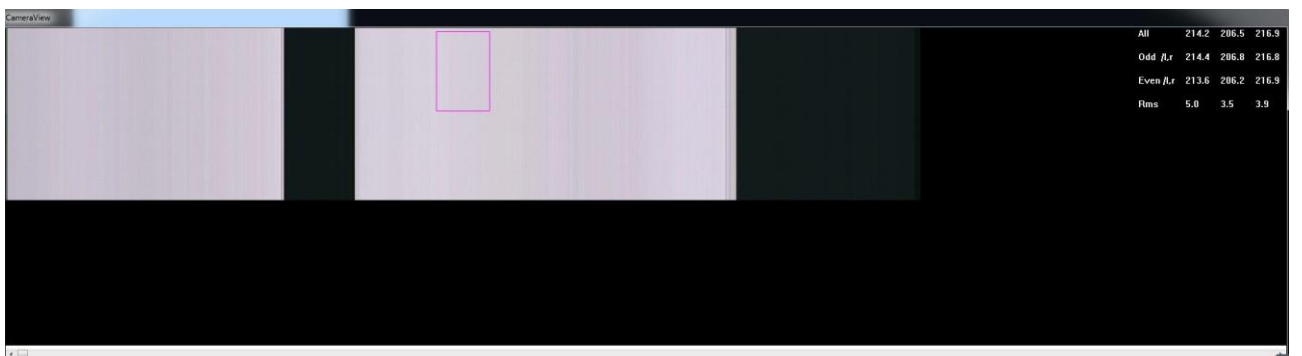
- Before Gain/Offset

### - Second OpHead Calibration
