| Preventive reference number | PMREPORT-242_PM855_2025-03-27 |
| Type: | iPQ Center / Dual Head Varnish |
| SN:WA: | ASO056723 _ WA19752 |

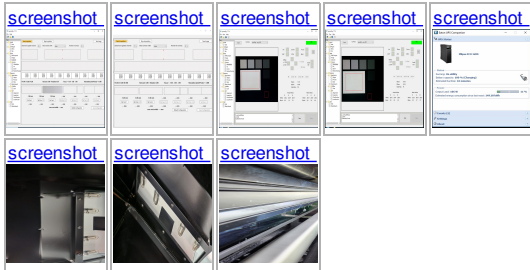
| | | COMMENTS | | | COMMENTS |
|---|---|---|---|---|---|
| Traversewscamerareplaceflashbulb | ⏸ | A remplacer au prochain préventif, surtout cam recto, voir photos | Version upgraded | | 2.17.9 |
| Led checking+reflector checking+dome | ✗ | Backflash rayé | | | |

Test du PDF compare OK, mais pas de fichier fonctionnel.  
Flash matricielle à remplacer au prochain prøventif.
