## Visit Report

| Customer : | J.P.C. Etiquettes | System : | TubeScan DS 330 4K |

| Details | Maintenance Préventive du Tubescan 330 4K sur BOBST M4. Repositionnement mécanique du codeur. Mise à jour du système. |

System Type : DS 330 4K / M2089aC-0.1111

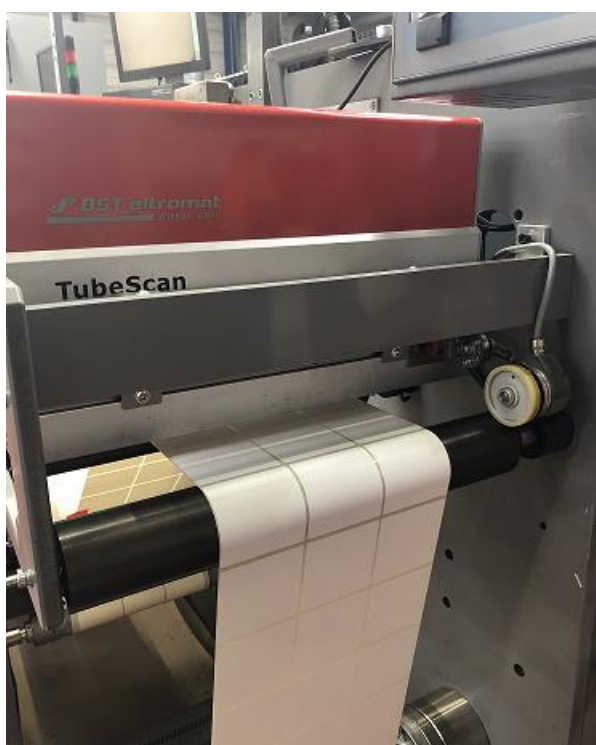
- Déplacement du codeur
