## Visit Report

| Customer : | Adhex Technologies | System : | TubeScan DS 330 CP |

| Details | Maintenance Préventive du système TubeScan sur presse Mark Andy XP5000-13A. Mise a jour du software |

## Maintenance Checklist for NYQUIST Systems

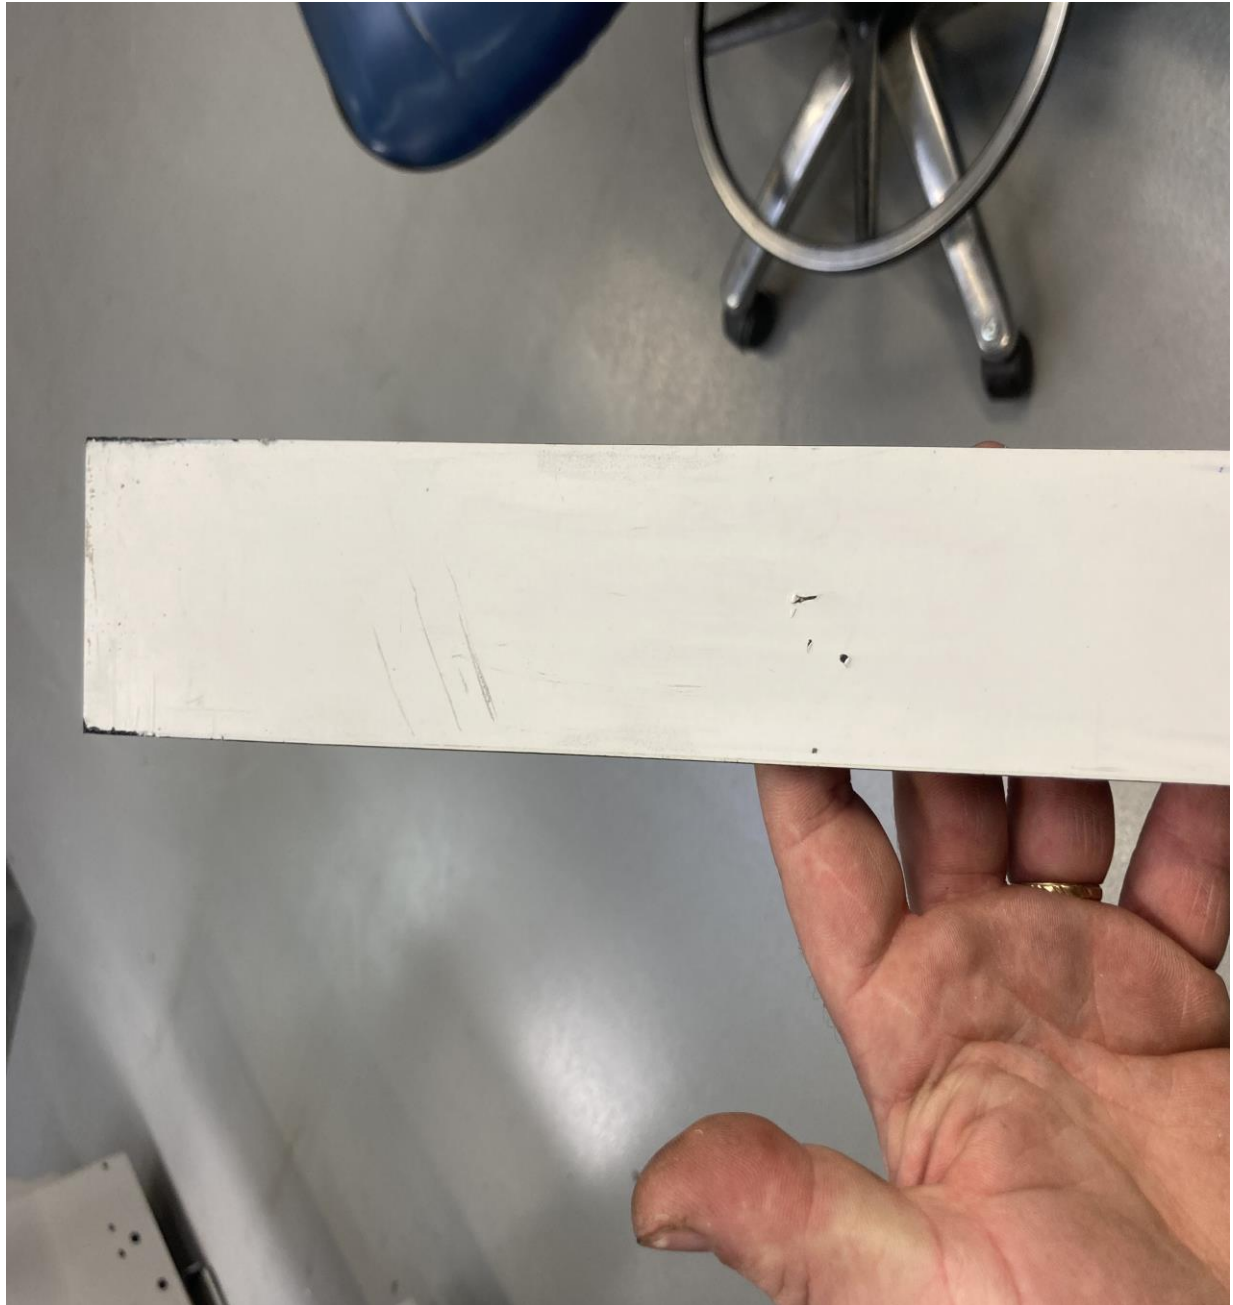
## Notes

| 1 – <a href="#">Backplate(voir notes)</a> | 3 - |
