## Visit Report

| Customer : | CPC Cotentin | System : | iPQ Center |

## Maintenance Checklist for iPQ systems

Machine Manufacturer/Model/Nickname : [Bobst / RS 6003 CHS / Bobst](#)

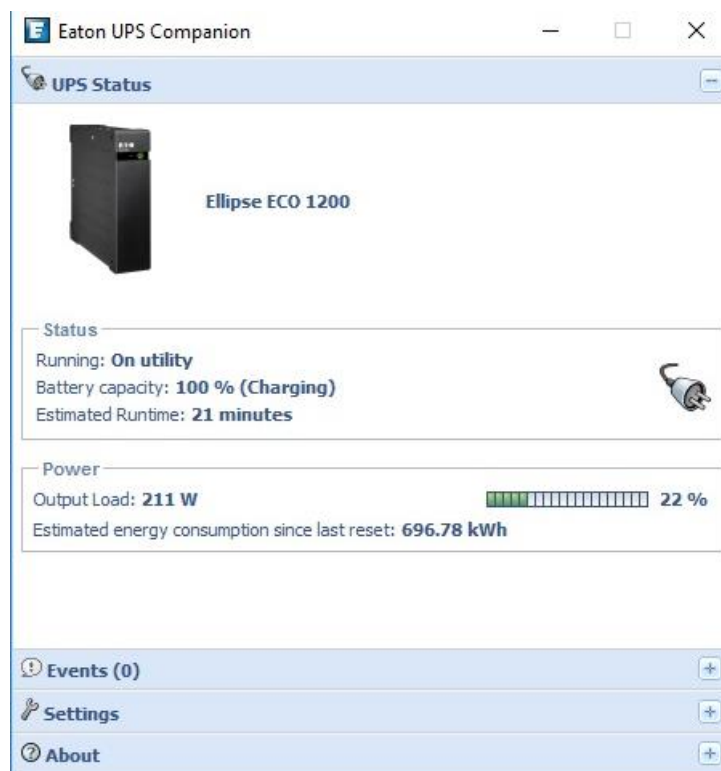
### 4- UPS

**10. Exchange the UPS battery according to iPQ-Check maintenance.**
☒ ☐ ☐

- Model : [ELIIPSE ECO 1200](#) Date : [2018](#)

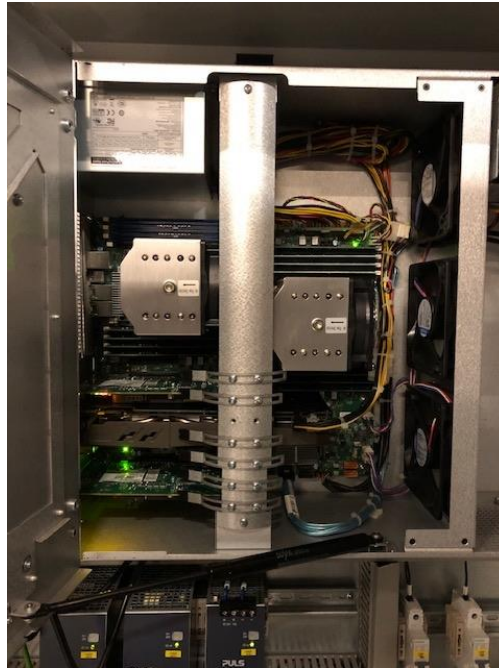
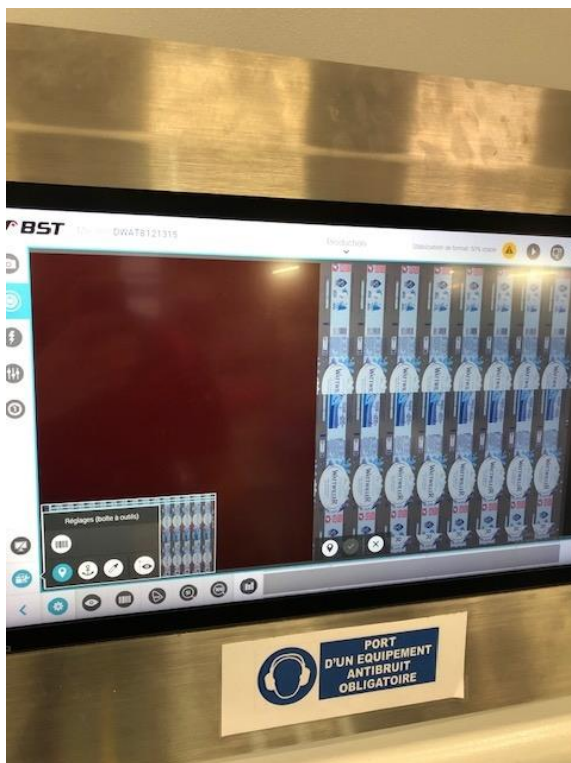
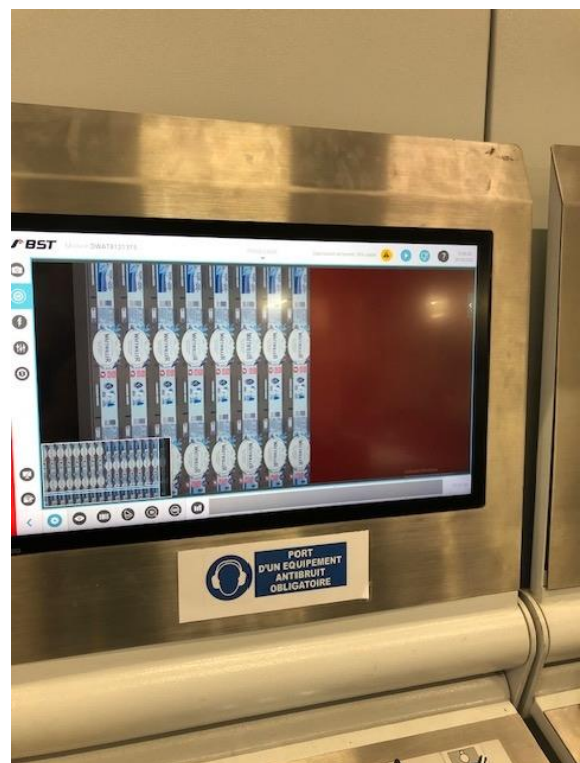
- 6- 3 RAM Board déplacées vers slot libre - 36GB/48GB visible avant intervention. Camera freezées a grande vitesse.
