## Visit Report

| Customer : | CCL Package Label | System : | TubeScan DS 330 4K |

| Details | Maintenance Préventive du système TubeScan sur presse Gallus EM 285.<br>Mise a jour du système .UPS verifier |

## Maintenance Checklist for NYQUIST Systems

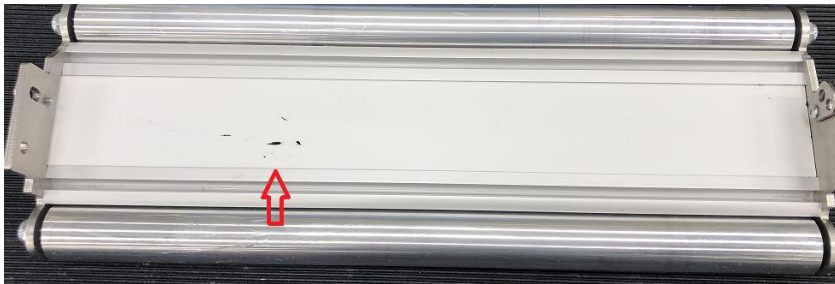
- White/Black back plate scratched.

| 1 - White/Black back plate | 3 - |

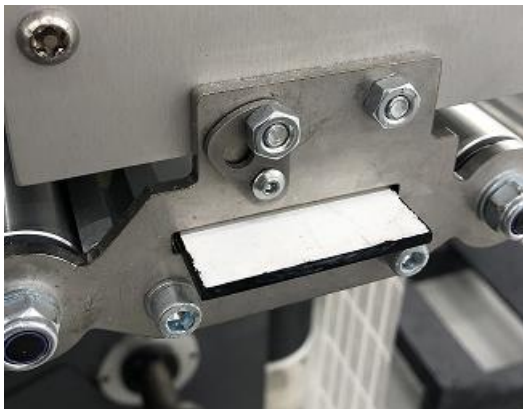
- Screws for Roller Backing Bar missing
