## Visit Report

| Customer : | MCC (Ablis) | System : | iPQ Check Eco |

| Details | Maintenance Préventive du système iPQ Check Eco sur presse DCM8GV. Calibration Shadding + white sur outil BST. Backup. |

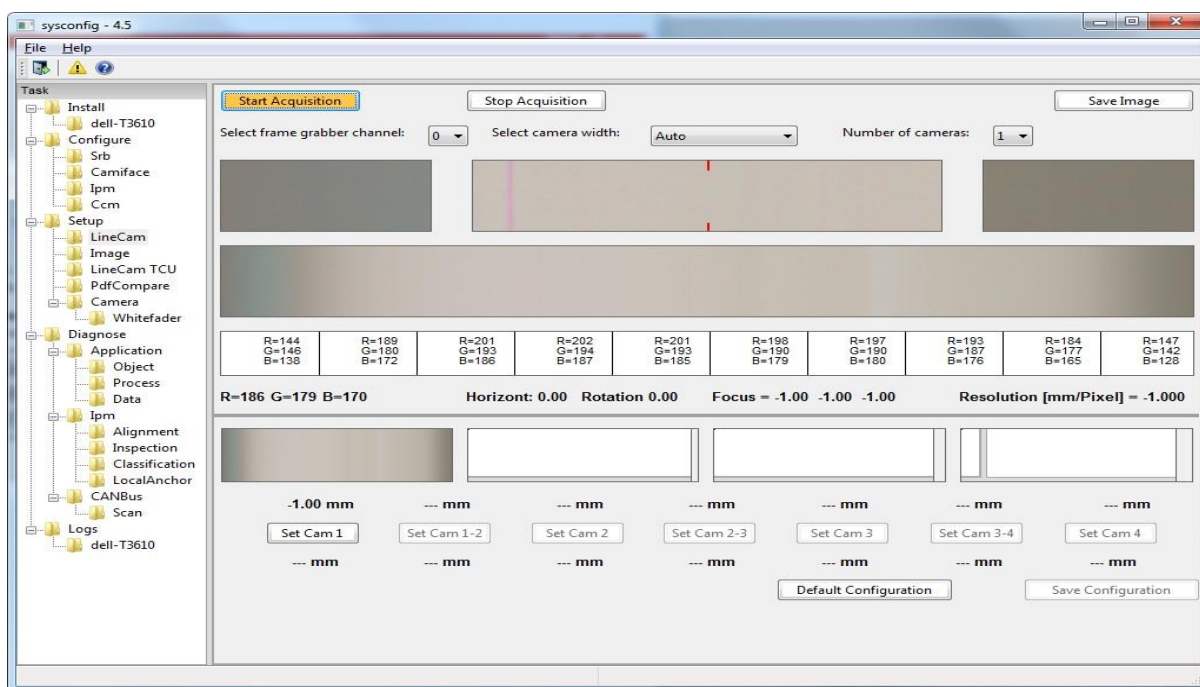
Before Shadding + White calibration
