## Visit Report

| Customer : | Vandeweghe nv-Flexo Printing | System : | Argus E Turbo 4K |

| Details | Maintenance Préventive du système d'inspection sur presse Comexi F4. Archivage.<br>Calibration du champ de vision et des GAIN |

## Maintenance Checklist for AVT Systems

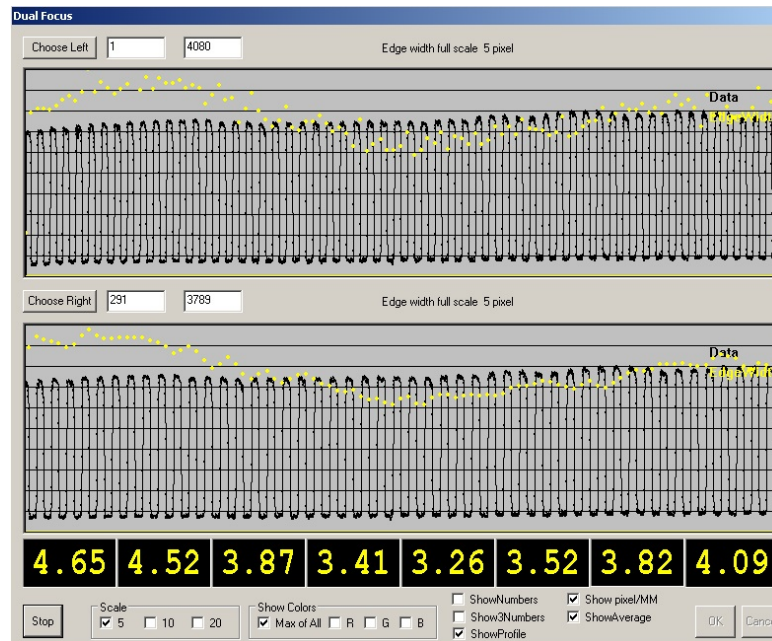
### Station1-**Main OpHead**-CDalsaPiranha4

## 2 – LCCD Focus Calibration

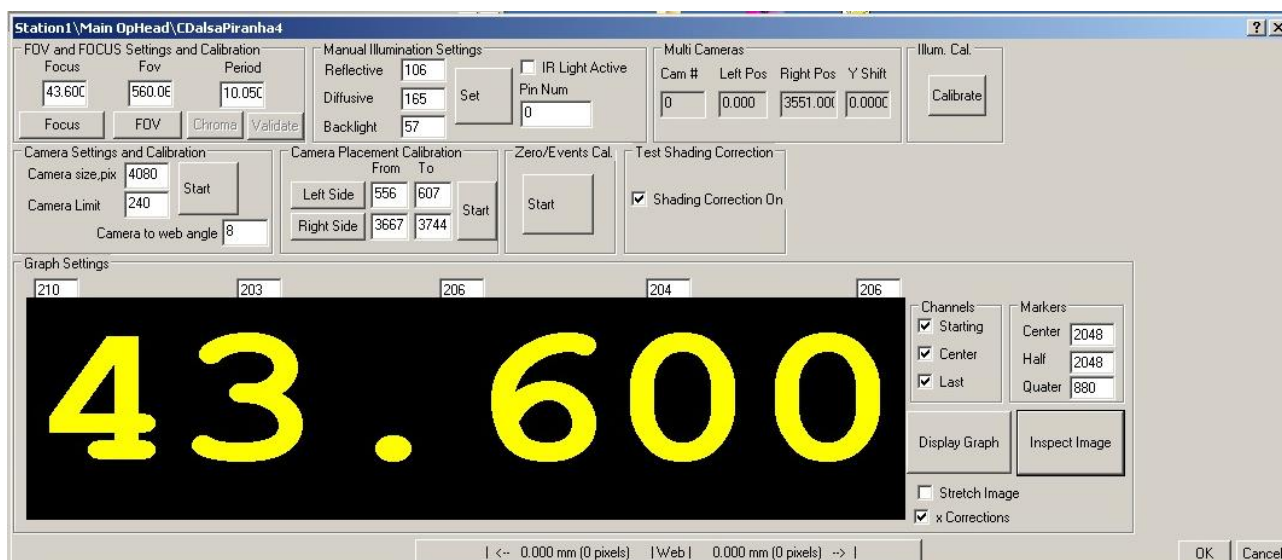
### Station1-**Main OpHead**-CDalsaPiranha4

Main : 560.08 mm / 10.05

## 3 – LCCD Field of View Calibration

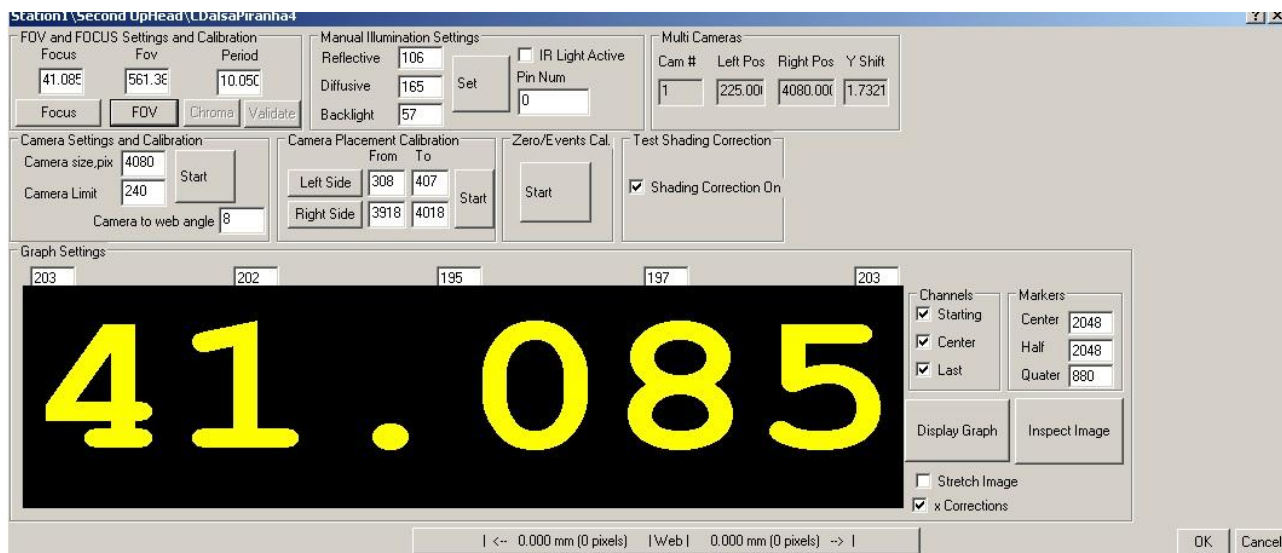
### Station1-**Second OpHead**-CDalsaPiranha4

Second : 561.38 mm / 10.05
- Offset/Gain Calibration. ☐☐☒
- Zero LED calibration : Any/Zero/Dig ☐☐☒ Events

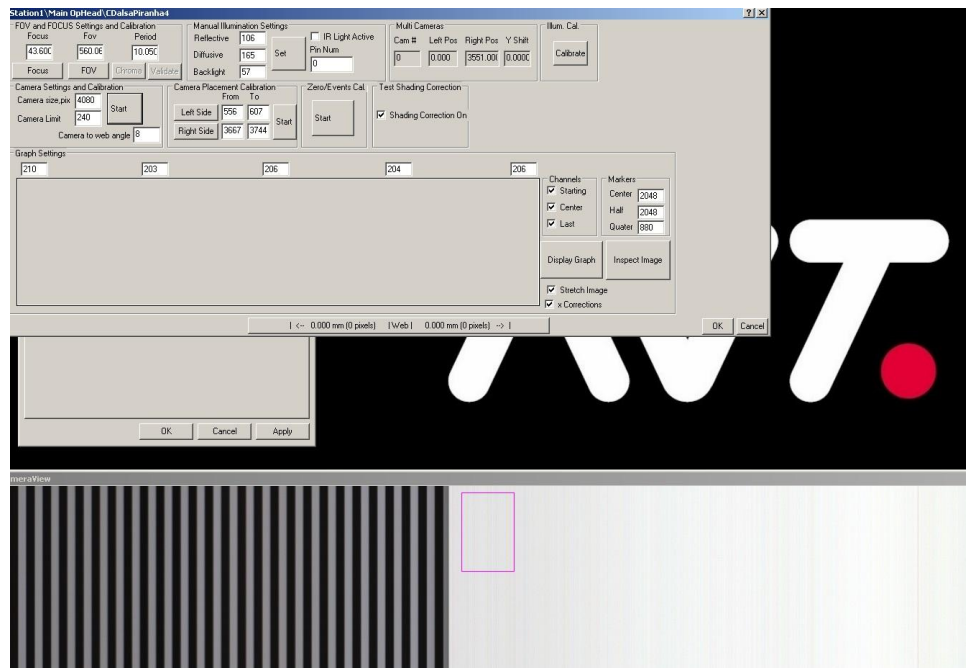
##### Station1-**Main OpHead**-CDalsaPiranha4

#### 4 – Gain Calibration
