## Visit Report

| Customer : | Amcor Sarrebourg | System : | iPQ Center |

| Details | System upgrade until latest release version. Inspection filter "Material" implemented. Protocol style sheet and defect summary on Quality Assistant configured. Unlimited jobs enabled. HDD for data collection installed on press 253 and replaced on press 249. Full system backup. |

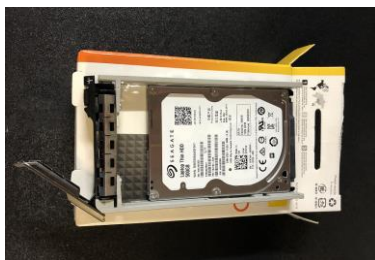
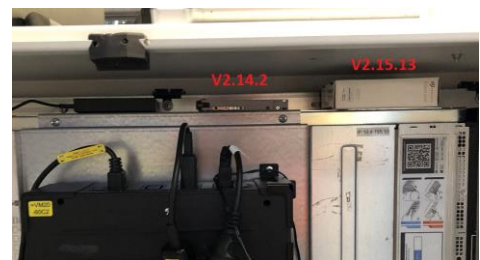
### 1- System upgrade to latest release version

- New base image installed on new HDD on v2.17.1. Working spare HDD with 2.15.13 and working original HDD ready just in case. They will be used during next upgrade on press 249.
