## Visit Report

| Commande BSTe France : 232163 / AQ0018991 R3 (Service) | | Call : E1769 | |
| Customer : | Socoplan (Arcade Beauty) | System : | iPQ Check |
| Customer Order number : | N° 7137 / N° 7136 | Machine Nickname : | DCM 2 |

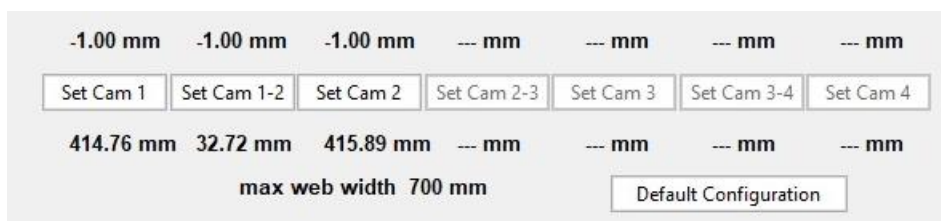
### - Etallonnage

Alignement des caméras + champ de vision calibré
