## Visit Report

| Customer : | Amcor Sarrebourg | System : | iPQ Center |

| Details | <p>System upgrade from v2.17.1 Non-Release to v2.17.1 Release.</p> <p>IllumProfiles / DiffuseDefval = 1.00 set for Screenshot from logo (Material filter).</p> |

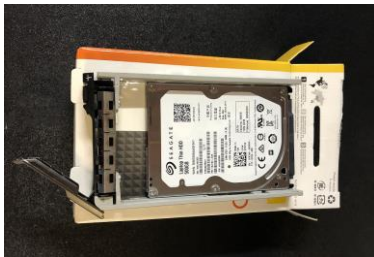
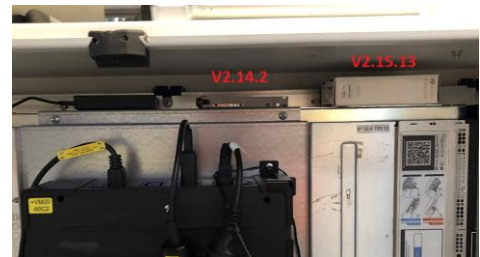
### 1- System upgrade to latest release version

- New base image installed on new HDD on v2.17.1. Working spare HDD with 2.15.13 and working original HDD ready just in case. They will be used during next upgrade on press 249.
