## TubeScan DS 660 sur Die Cutting machine Berhalter (566) / B6 (SN1360-CE-6)

### 4K Inspection Camera – DS 660 HR3

## **8K Inspection Camera – DS 660 8K**

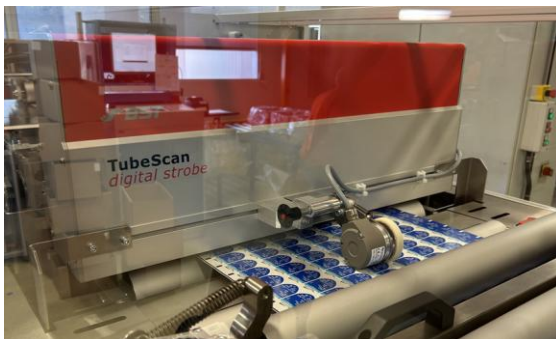
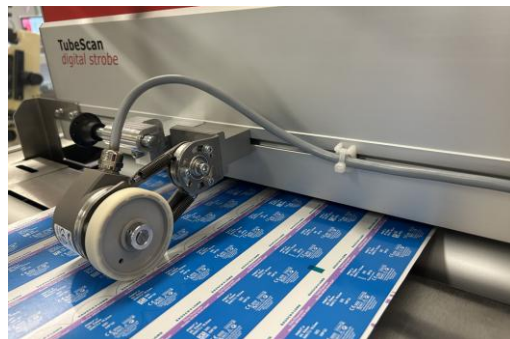
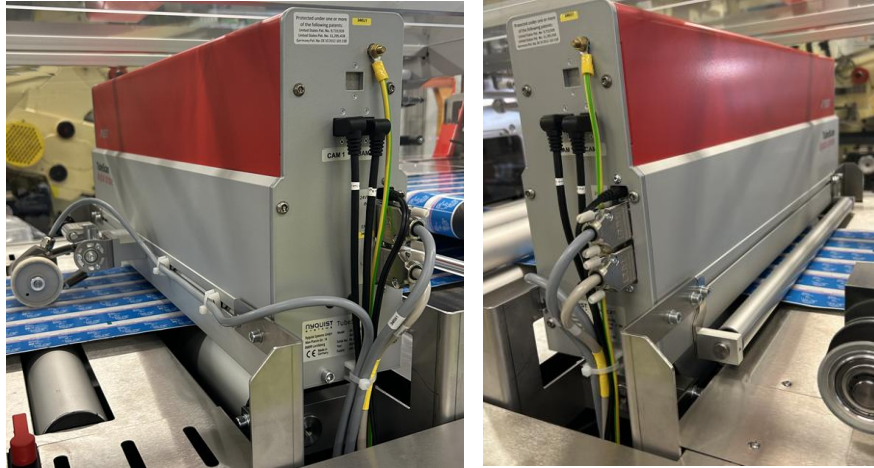
The camera assembly is mounted above a 200 mm roller with minimal contact area. The web travels nearly horizontally, with no contact on the exit roller where the encoder is installed.

Due to vibrations generated by the 566 machine itself, as well as resonance propagated from surrounding equipment, intermittent image distortion (stuttering effect) has been observed. This phenomenon limits the ability to fully leverage the system's inspection performance.

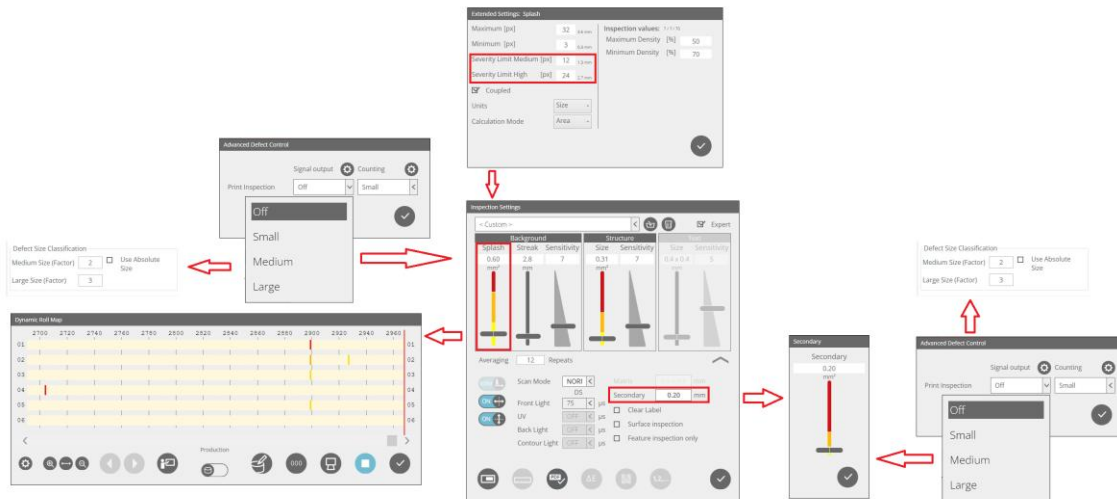
The tests were performed using 'Expert' sensitivity settings, exploring all available inspection modes and applicable inspection zones.

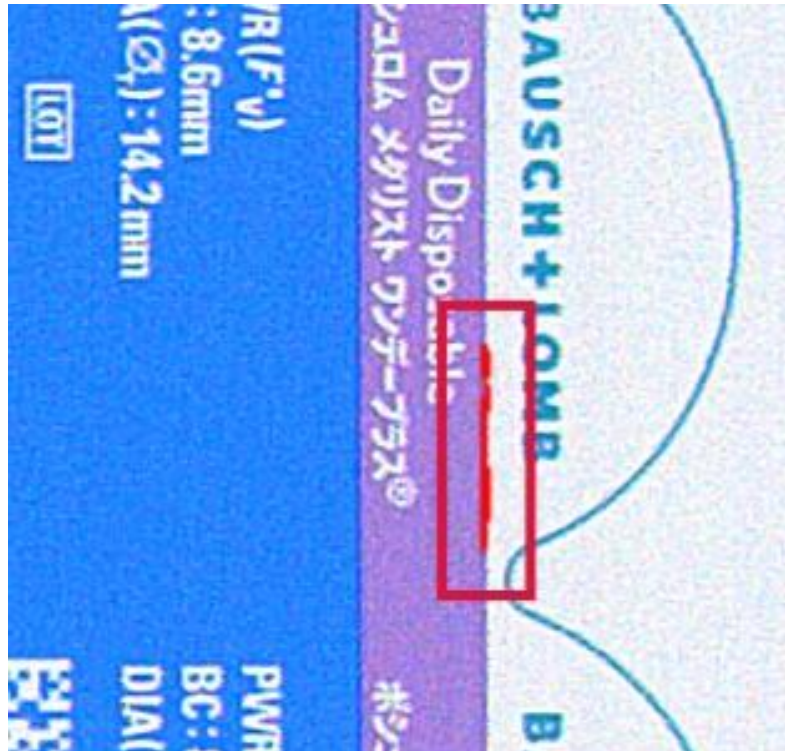
Final Assessment: Defects were intermittently captured. As the same defects could not be reproduced identically, a margin of uncertainty remains in the test results. Overall, line-type defects were detected inconsistently and in a non-repeatable manner..

The 0.17 mm<sup>2</sup> sensitivity setting could not be reliably used in structured zones due to residual vibrations. This resulted in false detections or artifacts in the 'Edge' areas.

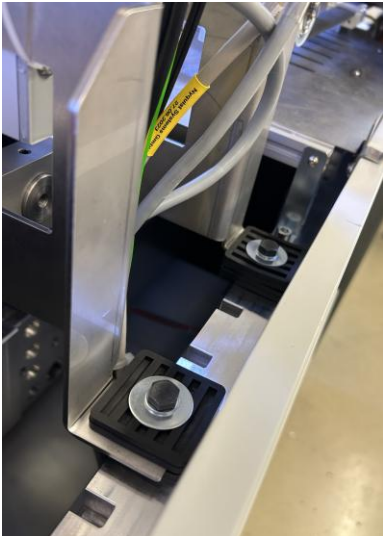
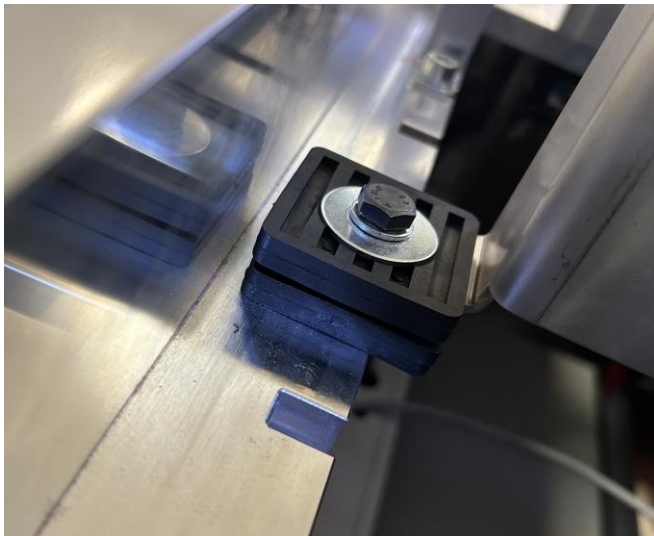
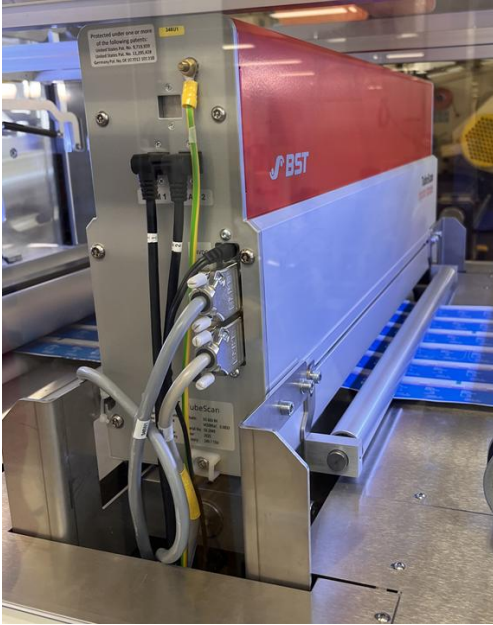
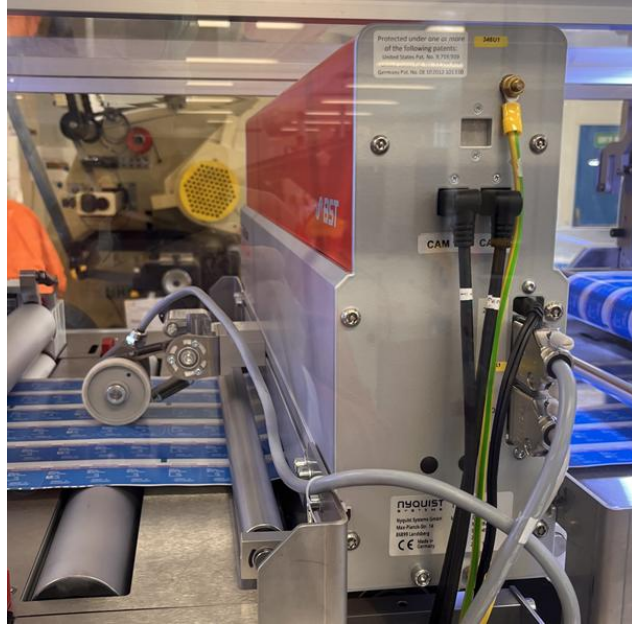
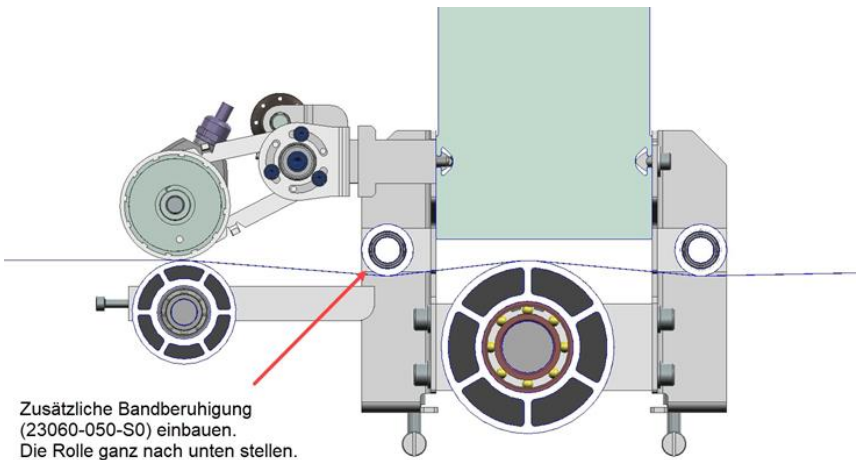
The vibrations generated by this machine were significantly reduced but not entirely eliminated.  
Shockwaves transmitted from nearby equipment remain perceptible.

The camera assembly was mounted on 4.7 mm rubber vibration dampers from Rakiuty. In addition to lowering the existing outfeed roller by 5 mm, a second identical roller was installed upstream of the camera under the same conditions.

These two rollers increase the contact surface on the support roller located beneath the camera, helping to stabilize the web. They also ensure proper web contact on the roller where the encoder is mounted.

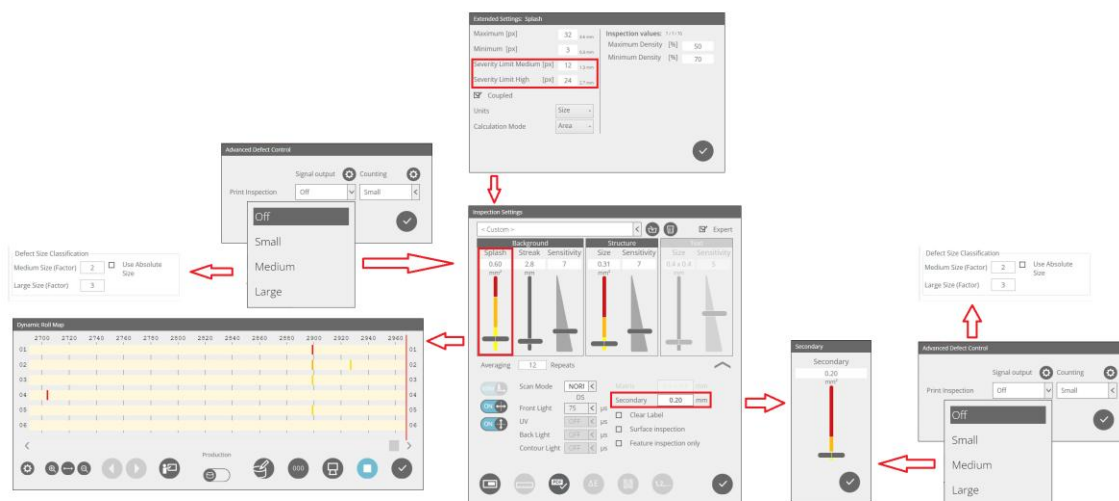
The tests were performed using 'Expert' sensitivity settings, exploring all available inspection modes and applicable inspection zones.
