## Visit Report

| Customer : | Sleeve International | System : | Helios S Turbo |
| Customer Order number : | 74122-210E-24 | Machine Nickname : | Roto 1 |

| Details | Réinstallation du système Helios S Turbo de la presse Roto 6 à la presse Roto 1. Maintenance préventive et paramétrage. Caméra Dalsa endommagée. |

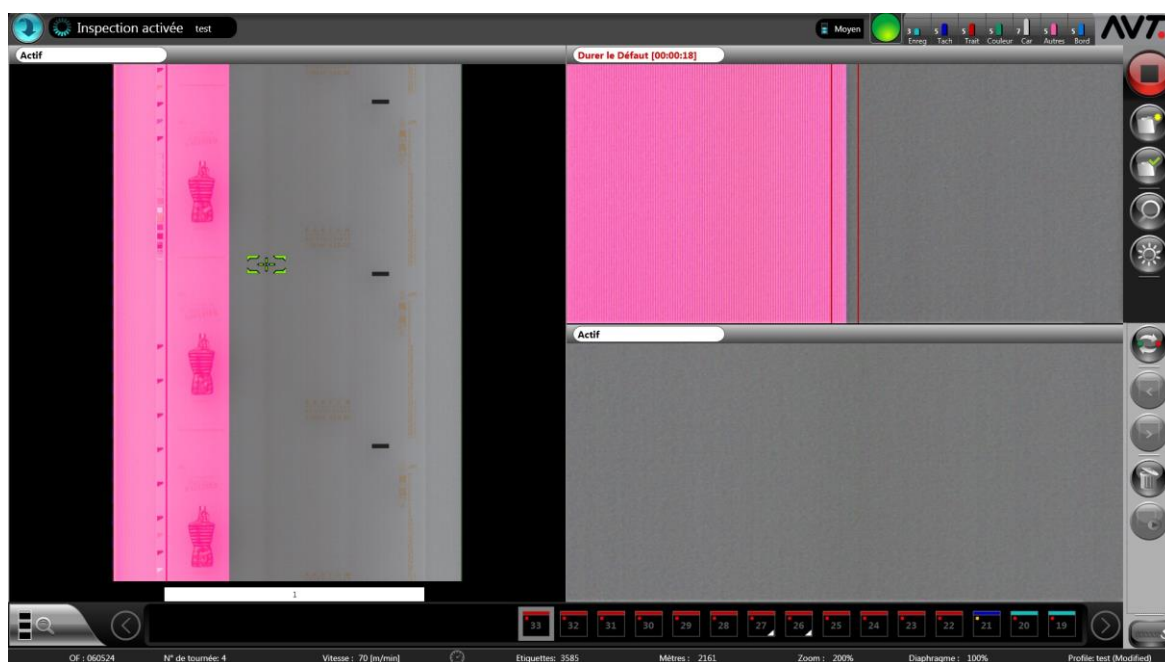
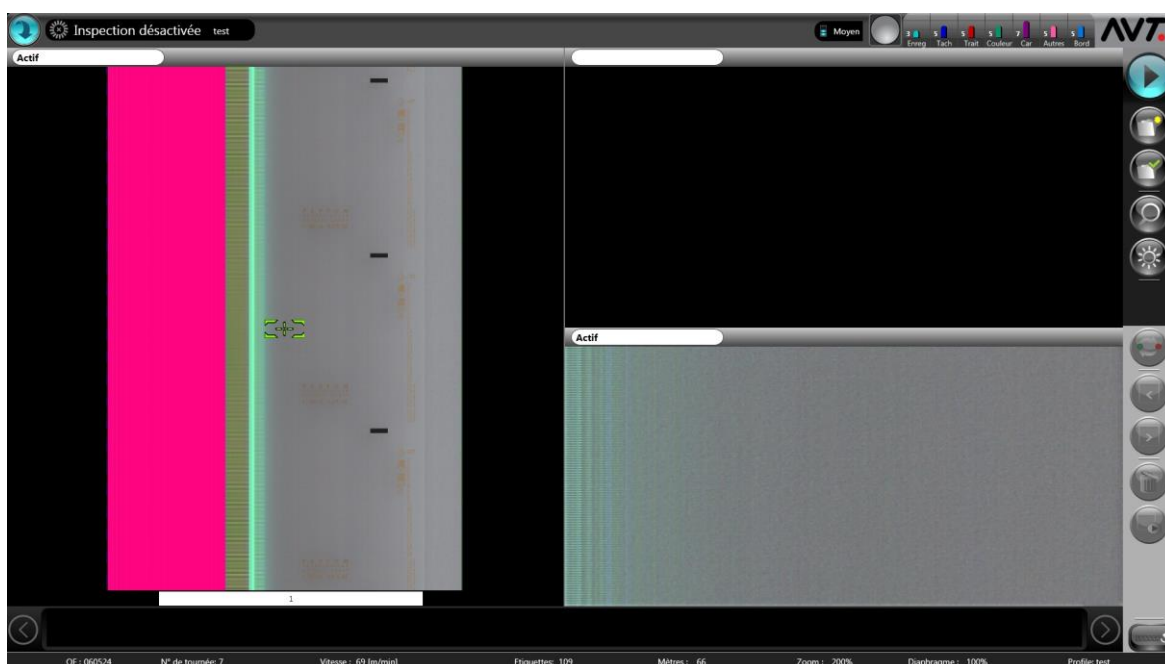
- Camera Dalsa Piranha4 (Euresys) defect :
