## Visit Report

| Customer : | RKW Saint Frères Emballage | System : | iPQ Center |

| Details | Installations IPQ-Center sur presse W&H + Instruction opérateurs. |

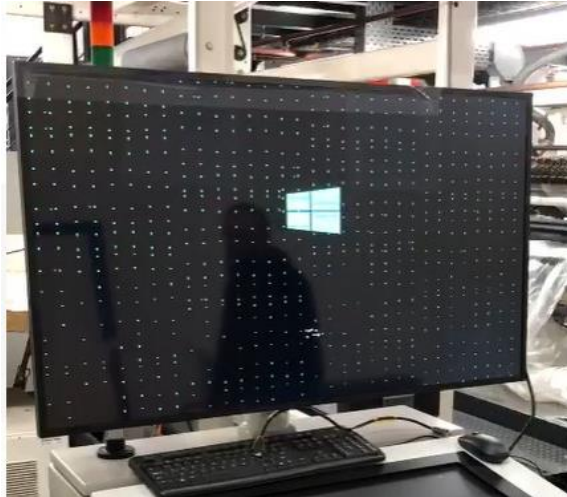
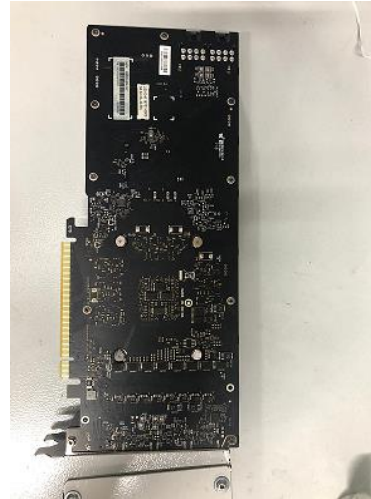
- Carte graphique NVIDIA remplacé
