## Visit Report

| Details | Maintenance préventive du système Registar_20 sur presse DCM BIVA 6 - Backup Acronis.<br>Changement carte Cfast. |

## Maintenance Checklist for Registar\_20

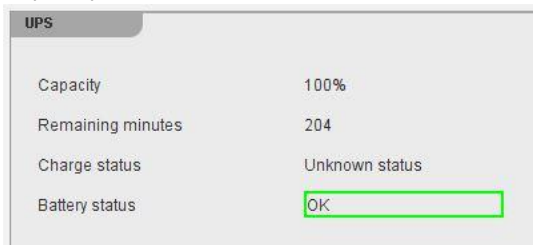
**1- Onduleur**

Vérification statuts UPS par logiciel interne maintenance BECKHOFF.

- Battery status : OK
- Capacity : 100%

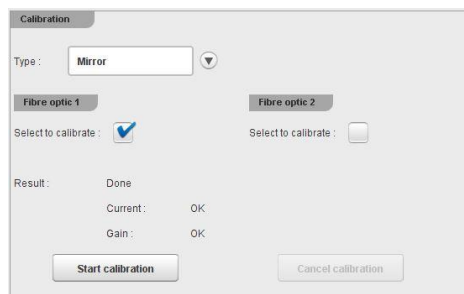
### 3- Nettoyage traverse support Fibre + Réflecteur/Miroir

| | PU2 | PU3 | PU4 | PU5 | PU6 | PU7 | PU8 | PU9 |
|---|---|---|---|---|---|---|---|---|
| Miroir | Clean | Clean | Clean | Clean | Clean | Clean | Clean | Clean |
| Traverse | OK | OK | VIS<br>FIXATION<br>NON<br>UTLISABLE | OK | OK | OK | ATTENTION<br>vis fixation | VIS<br>FIXATION<br>NON<br>UTLISABLE |

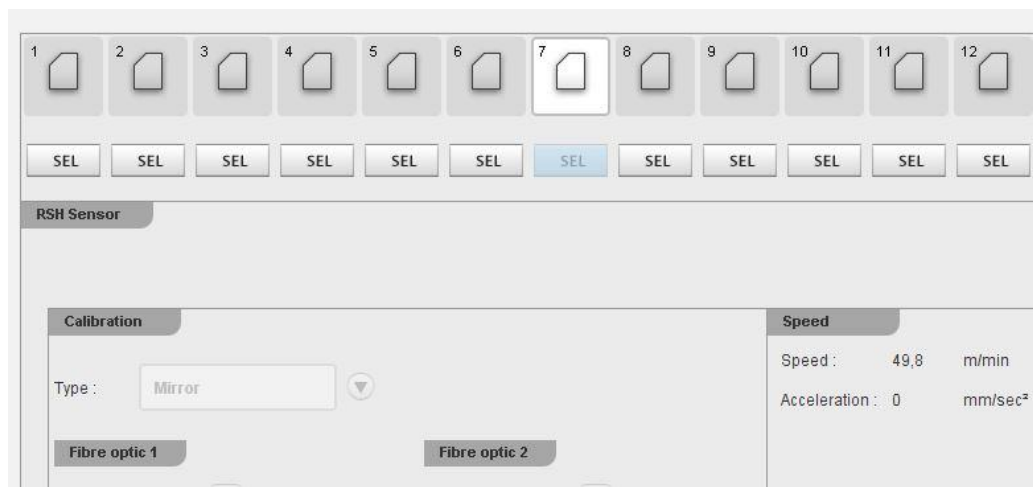
Affecter tous les groupes sur un nouveau job et vérifier en barbotage la vitesse et l'accélération des unités d'impression à l'aide de l'outil de mesure BST :

Vitesse Stable entre chaque Groupe d'impression.

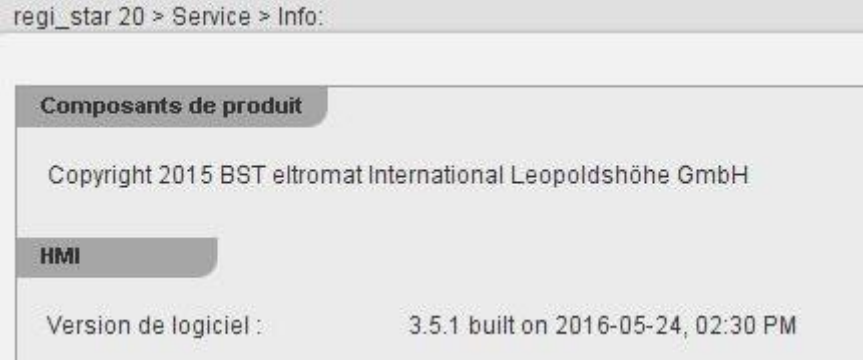
| Registrar Version | <p>regi_star 20 &gt; Service &gt; Info:</p> <p><b>Composants de produit</b></p> <p>Copyright 2015 BST eltromat International Leopoldshöhe GmbH</p> <p><b>HMI</b></p> <p>Version de logiciel : 3.5.1 built on 2016-05-24, 02:30 PM</p> |

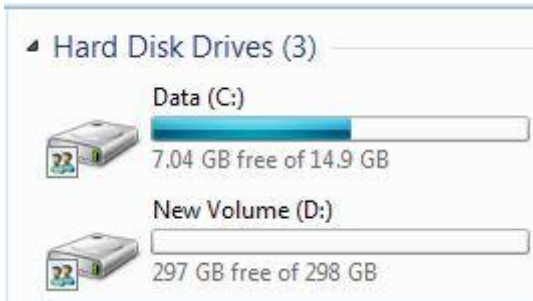
| Control Panel HDD | |

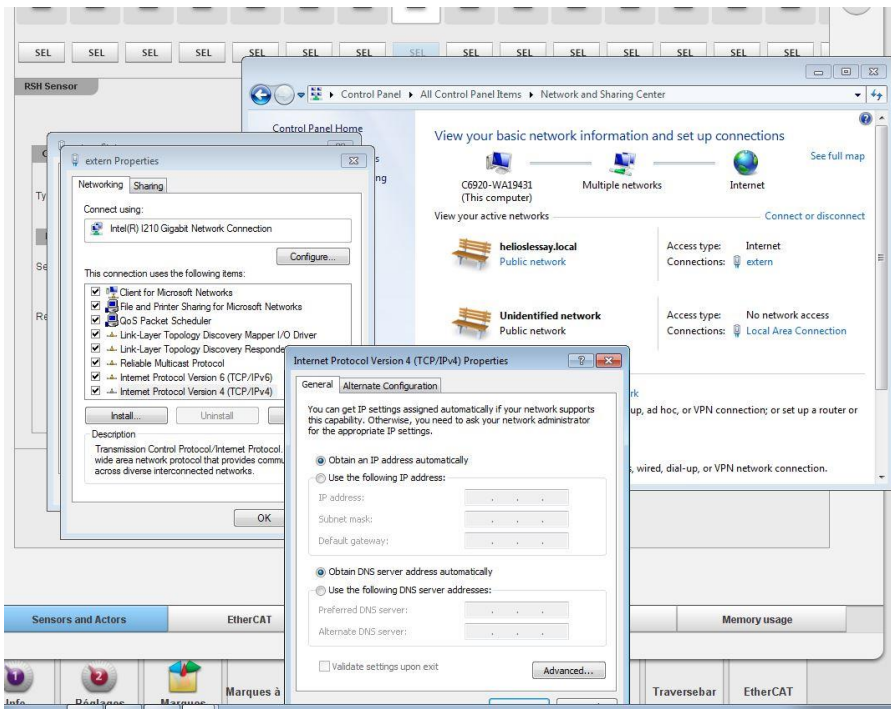
| Teamviewer ID ou adress IP MOROS | <p>Bypass moros and direct connection and set network as automatic</p> |
