## Visit Report

| Details | Maintenance préventive du système Registar_20 sur presse DCM BIVA 2. |

## Maintenance Checklist for Registar\_20

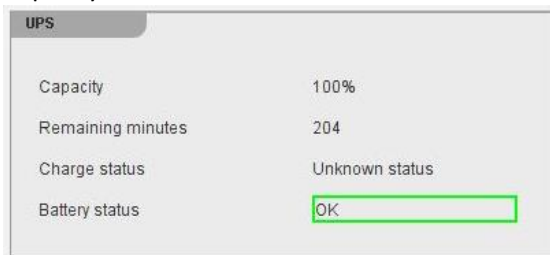
Vérification statuts UPS par logiciel interne maintenance BECKHOFF.

- Battery status : OK
- Capacity : 100%

Batterie a changé tous les 5 ans

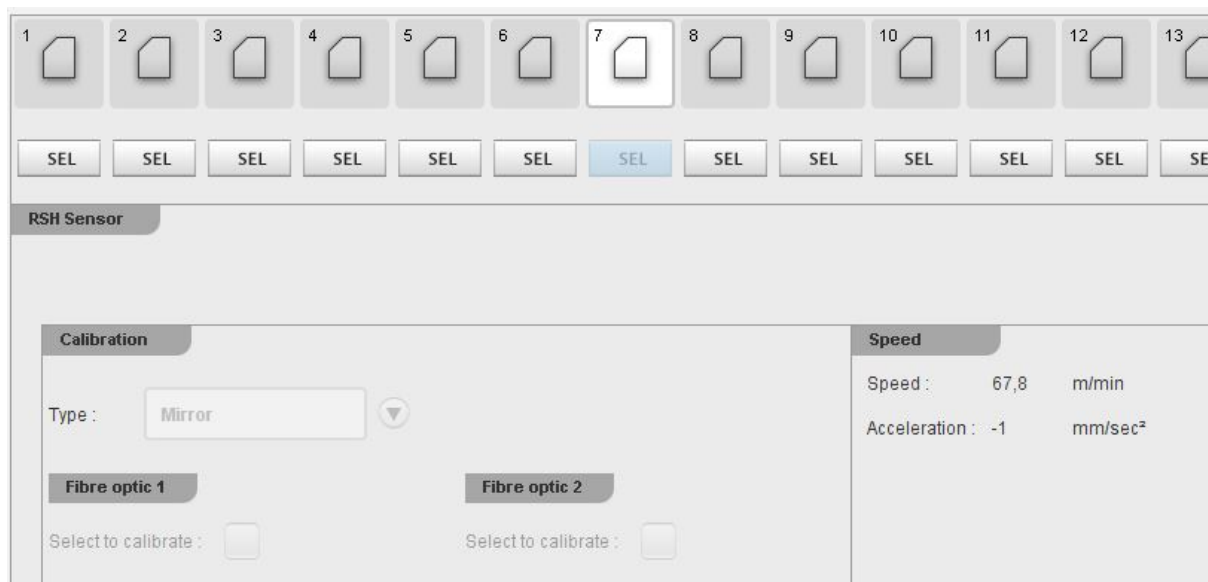
Affecter tous les groupes sur un nouveau job et vérifier en barbotage la vitesse et l'accélération des unités d'impression à l'aide de l'outil de mesure BST :

Vitesse Stable entre chaque Groupe d'impression. ATTENTION PU 6-7 VARIATION ACCELERATION, il faut vérifier accouplement ou motorisation

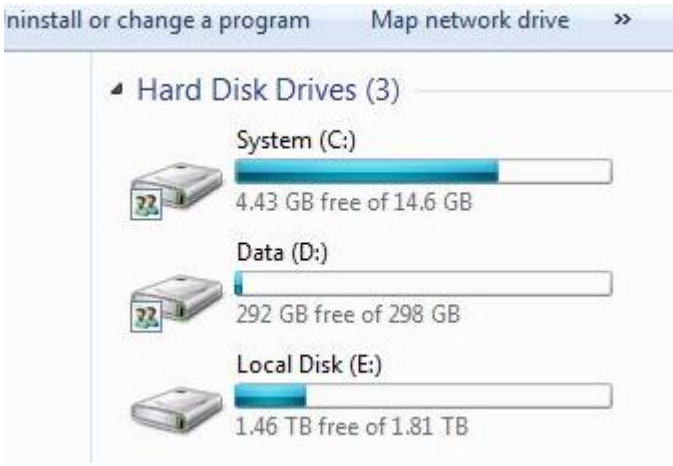
| Control Panel HDD | |

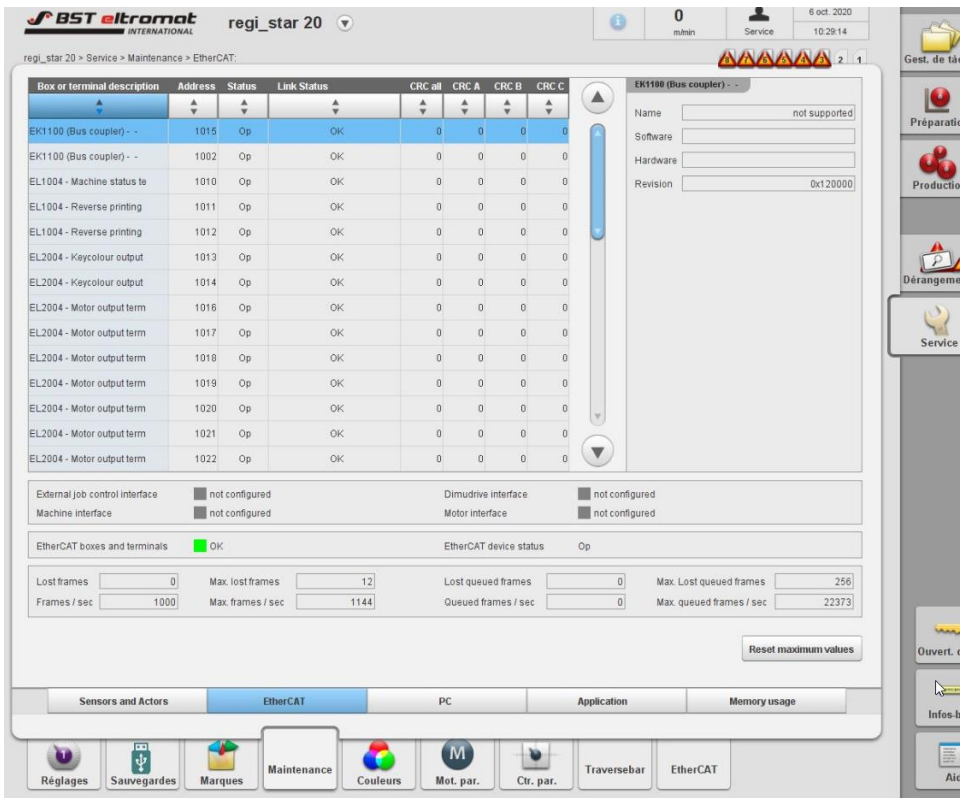
| Ethercat Status ? Message d'erreur. | <p>OK</p> |
