## Visit Report

| Details | Maintenance préventive du système Registar_20 sur presse DCM BIVA 6 . |

## Maintenance Checklist for Registar\_20

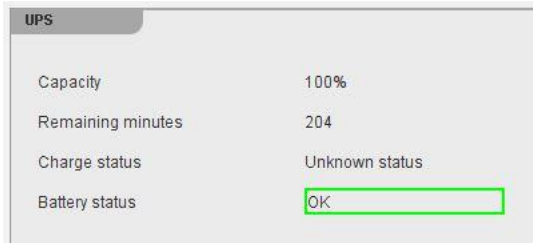
#### 1- Onduleur

Vérification statuts UPS par logiciel interne maintenance BECKHOFF.

- Battery status : OK
- Capacity : 100%

Batterie a changé tous les 5 ans/Changer 29/11/2023

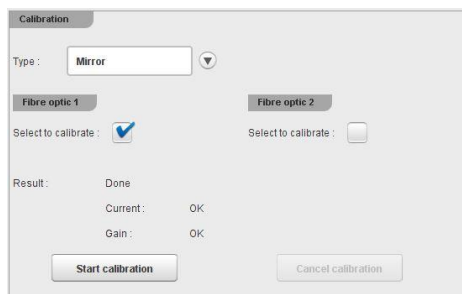
#### 2- Fibre de lecture de marque

Vérification structurelle des fibres coté support amovible. Nettoyage avec anti static product

Nombre de fibres optique par unité d'impression = 1 ou 2

Calibration des fibres par outils interne BST RSH Reference Box 0 Mirror Tube (PN 3BGSO325790)

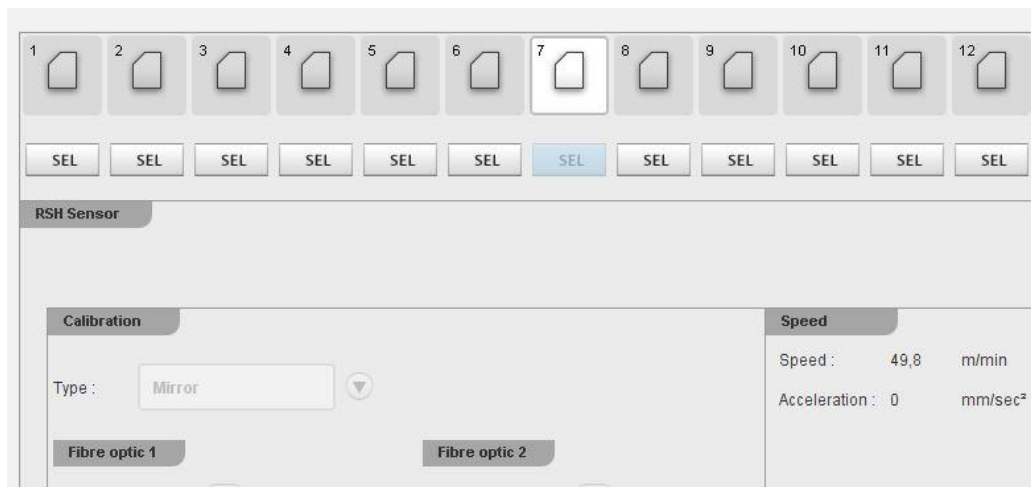
### Moteur indépendant :

Affecter tous les groupes sur un nouveau job et vérifier en barbotage la vitesse et l'accélération des unités d'impression à l'aide de l'outil de mesure BST :

Vitesse Stable entre chaque Groupe d'impression.

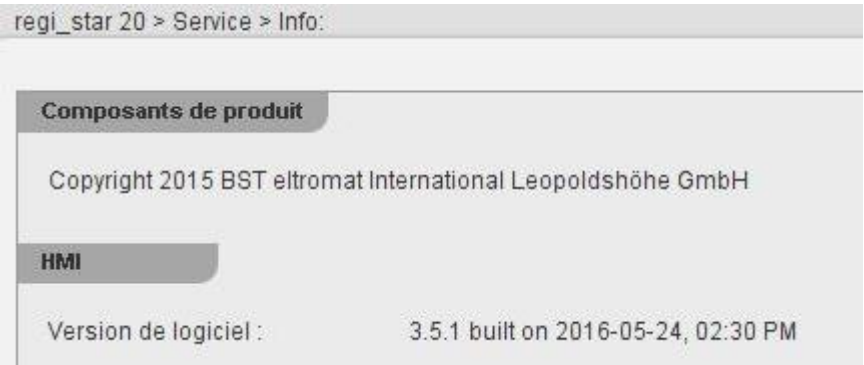
| Registrar Version | |

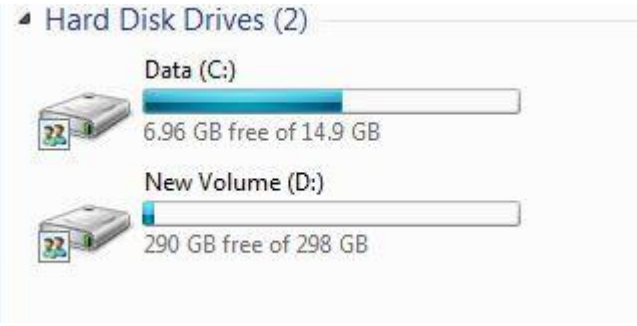
| <p>Ethercat Status ?</p> | <p>OK</p> |

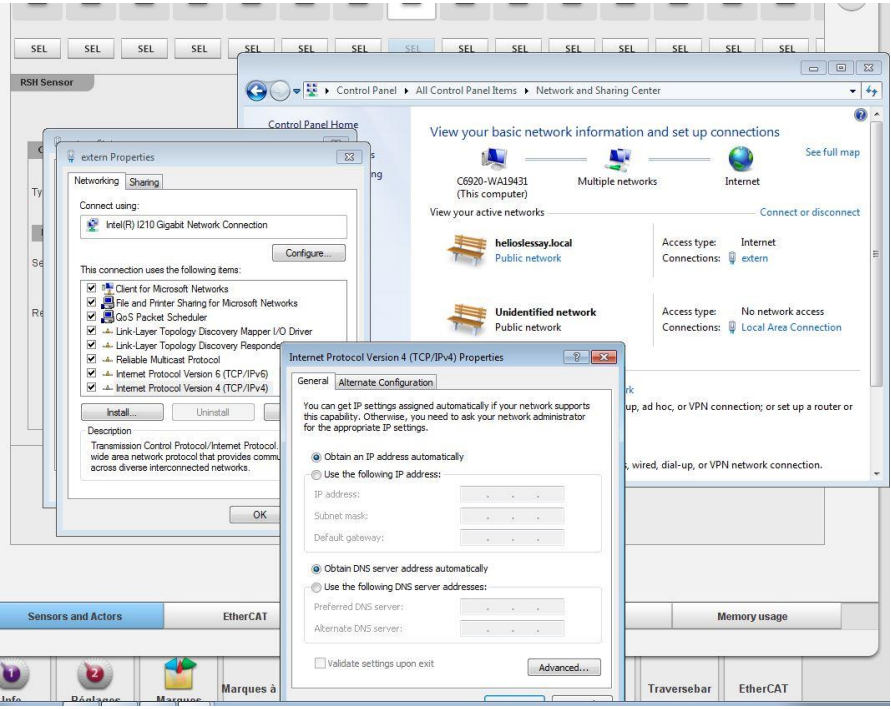
| <p>Teamviewer ID ou adress IP MOROS</p> | <p>Bypass moros and direct connection and set network as automatic</p> |
