## Visit Report

| Details | Maintenance préventive du système Registar_20 sur presse DCM BIVA 2. Backup Acronis. |

## Maintenance Checklist for Registar\_20

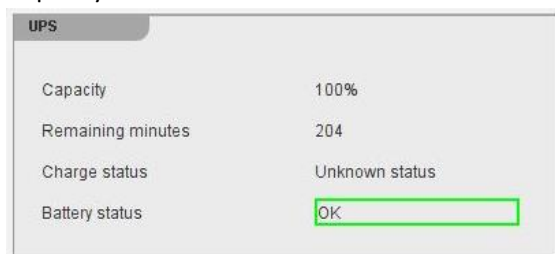
**1- Onduleur**

Vérification statuts UPS par logiciel interne maintenance BECKHOFF.

- Batterystatus : OK
- Capacity : 100%

Batterie a changé tous les 5 ans

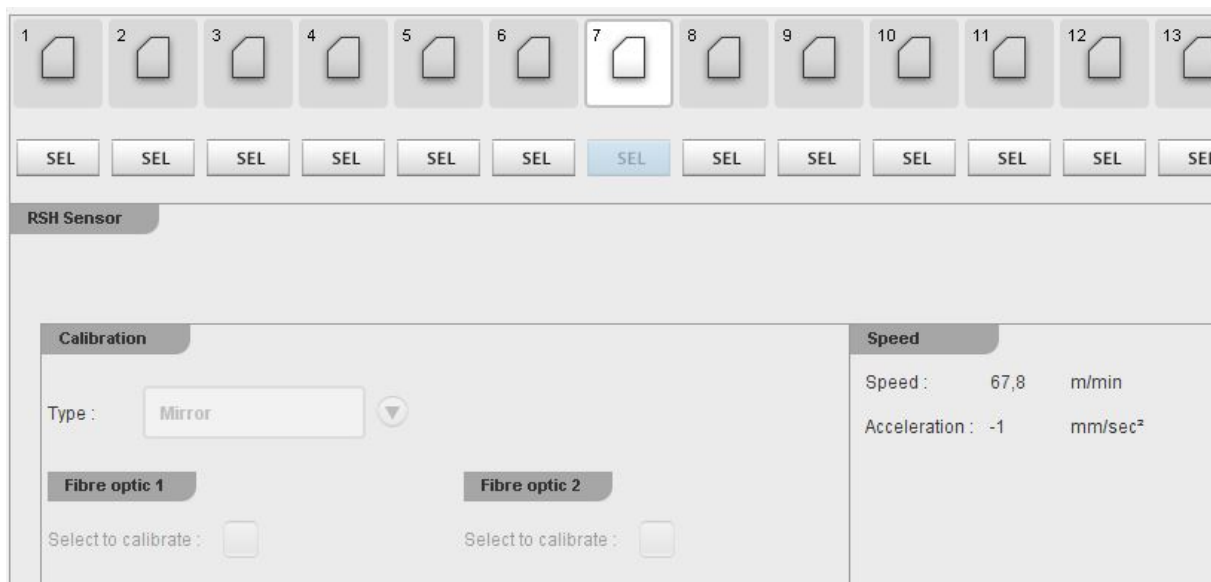
##### Moteur indépendant :

Affecter tous les groupes sur un nouveau job et vérifier en barbotage la vitesse et l'accélération des unités d'impression a l'aide de l'outil de mesure BST :

Vitesse Stable entre chaque Groupe d'impression. ATTENTION PU 6-7 VARIATION ACCELERATION, il faut vérifier accouplement ou motorisation

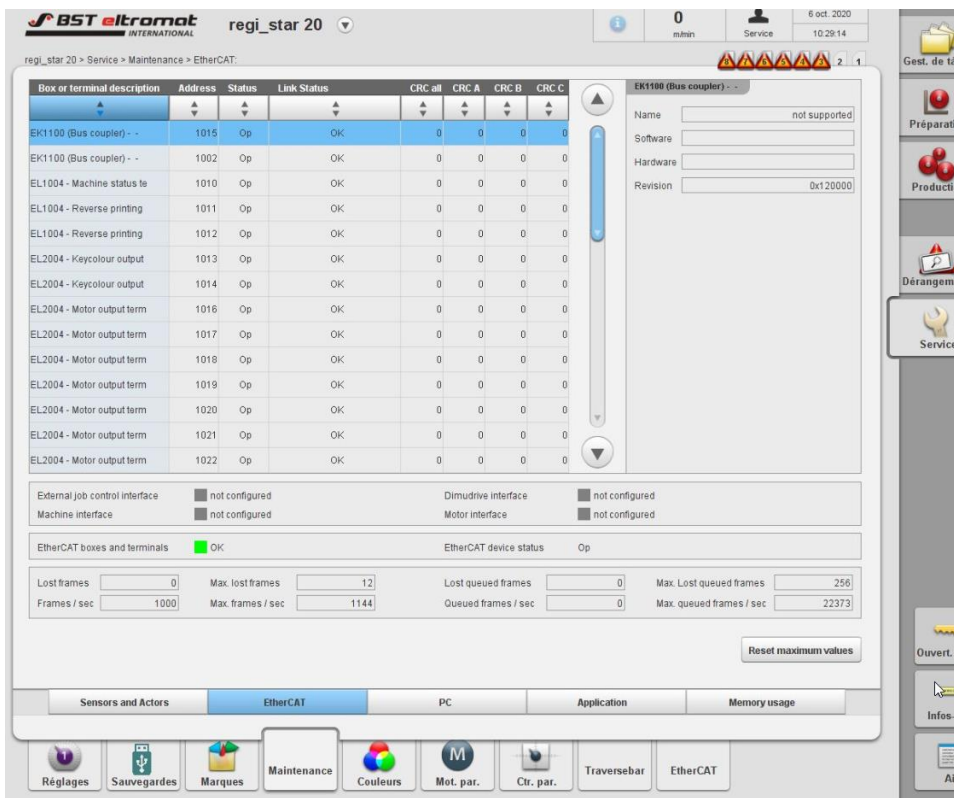
| Ethercat Status ? Message | OK |
